## MEMORANDUM

**SUBJECT:** Informational presentation on the Port's Rapid Structural Assessment Program.

### EXECUTIVE SUMMARY

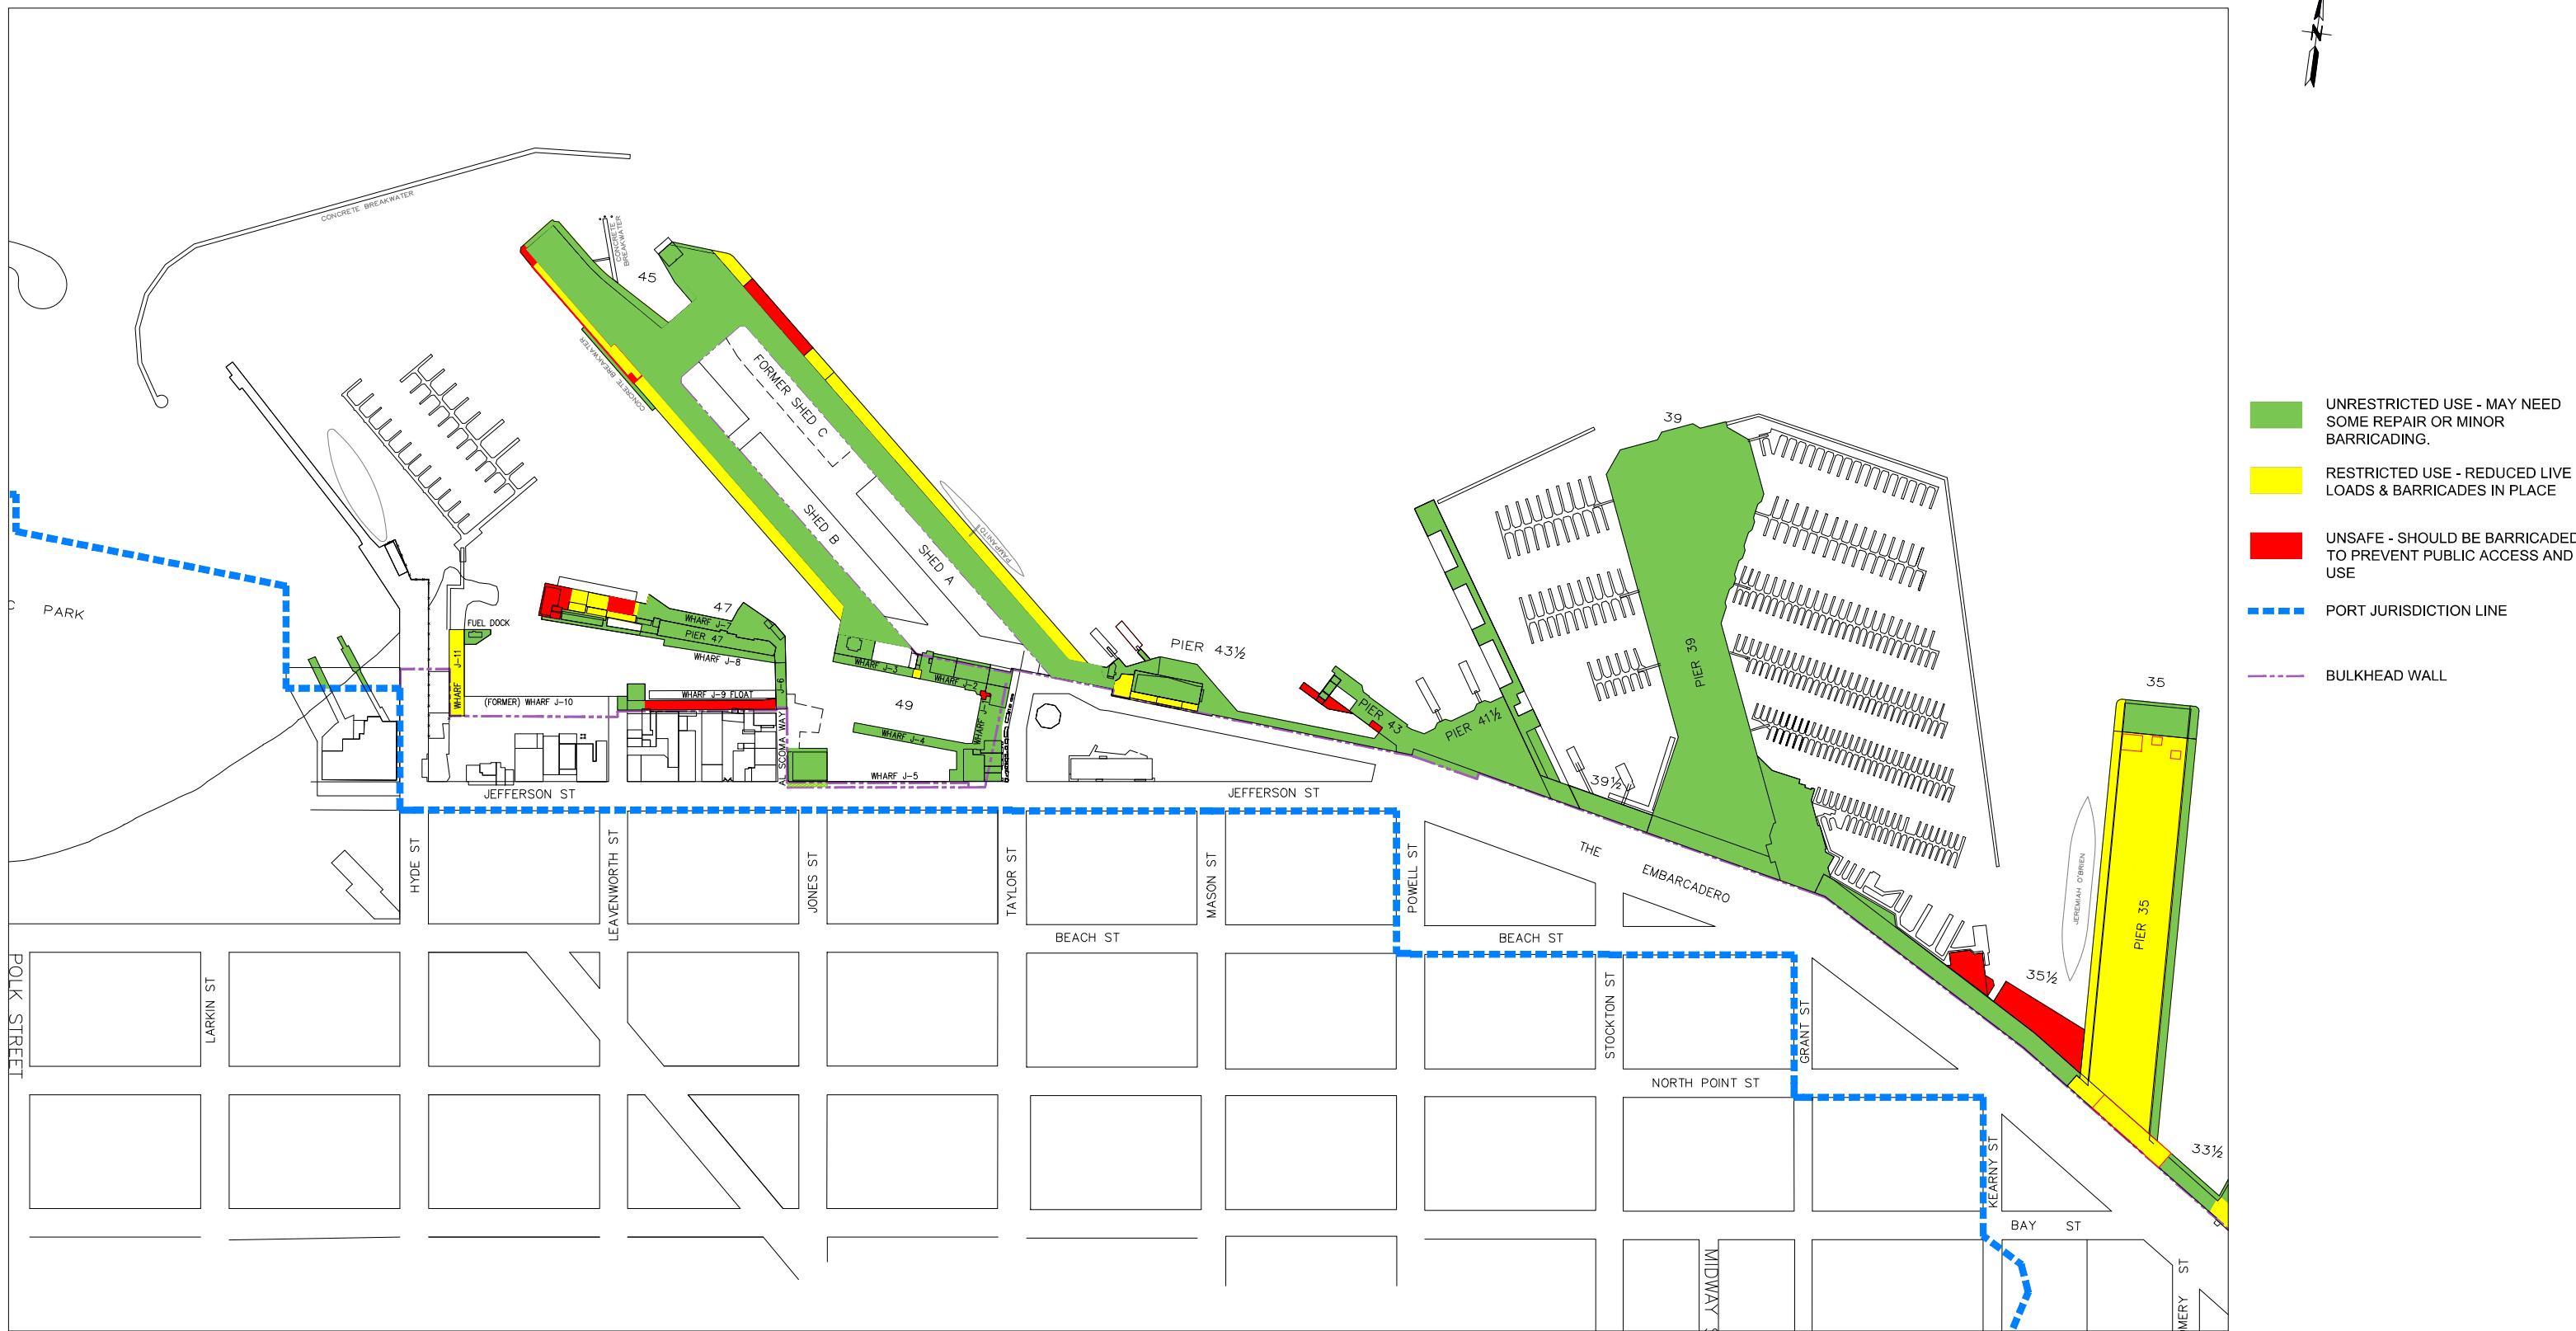
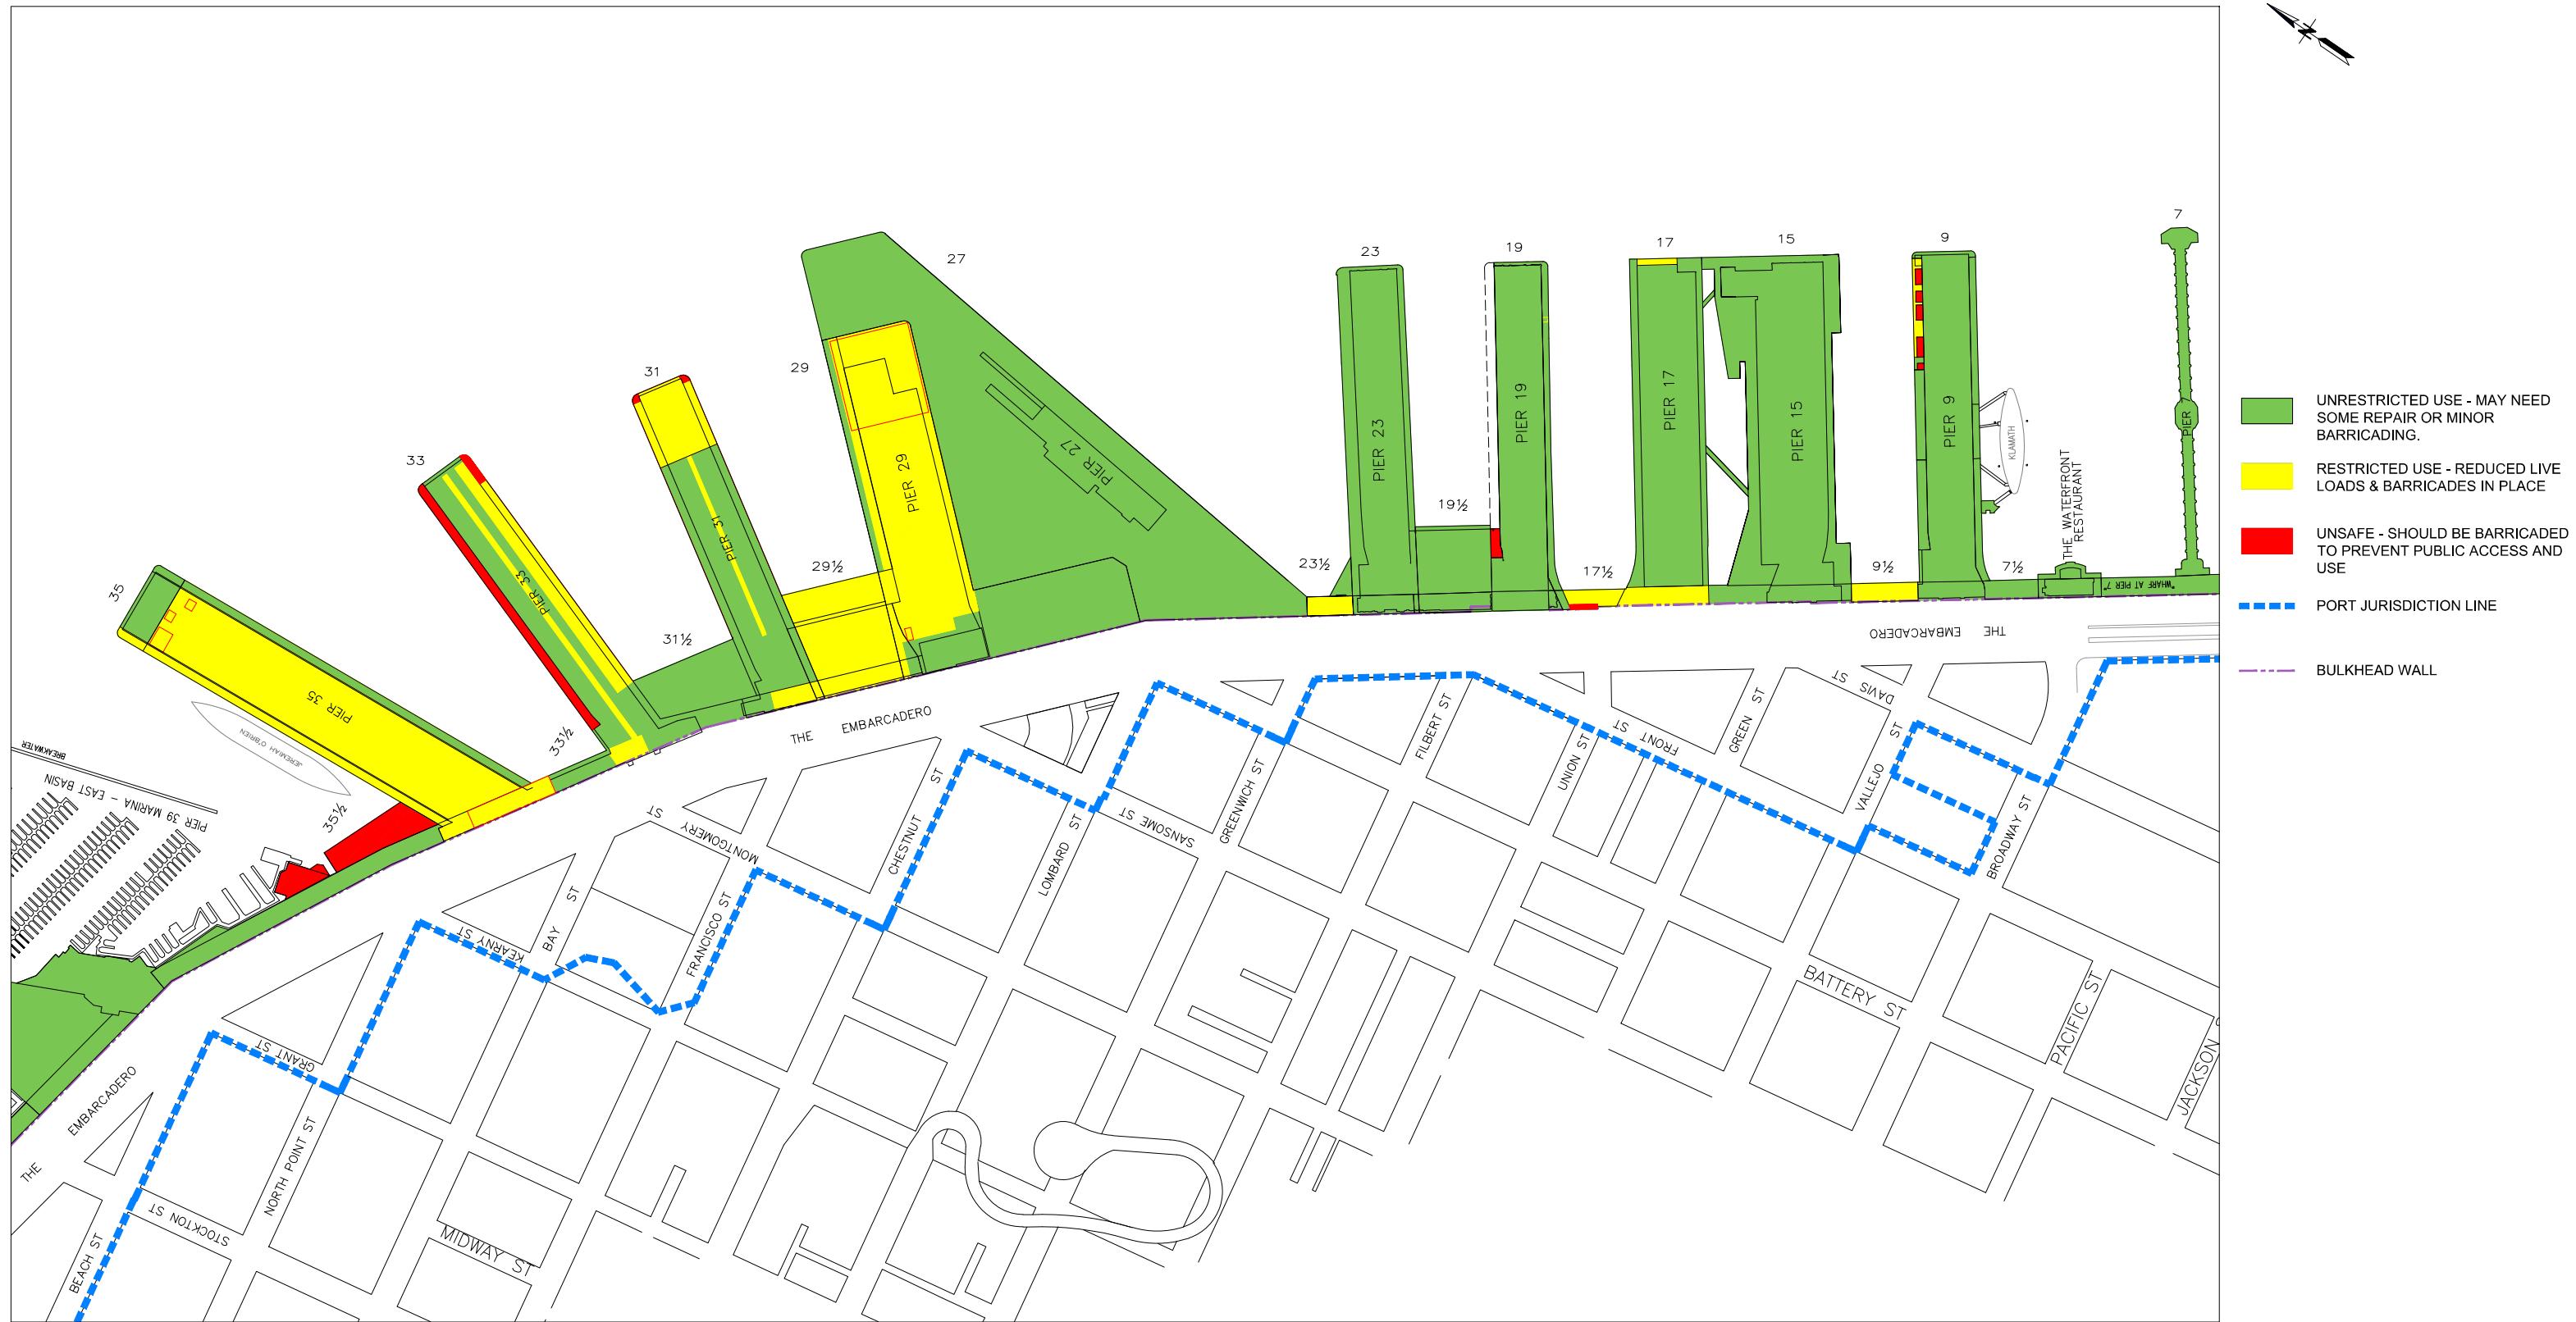
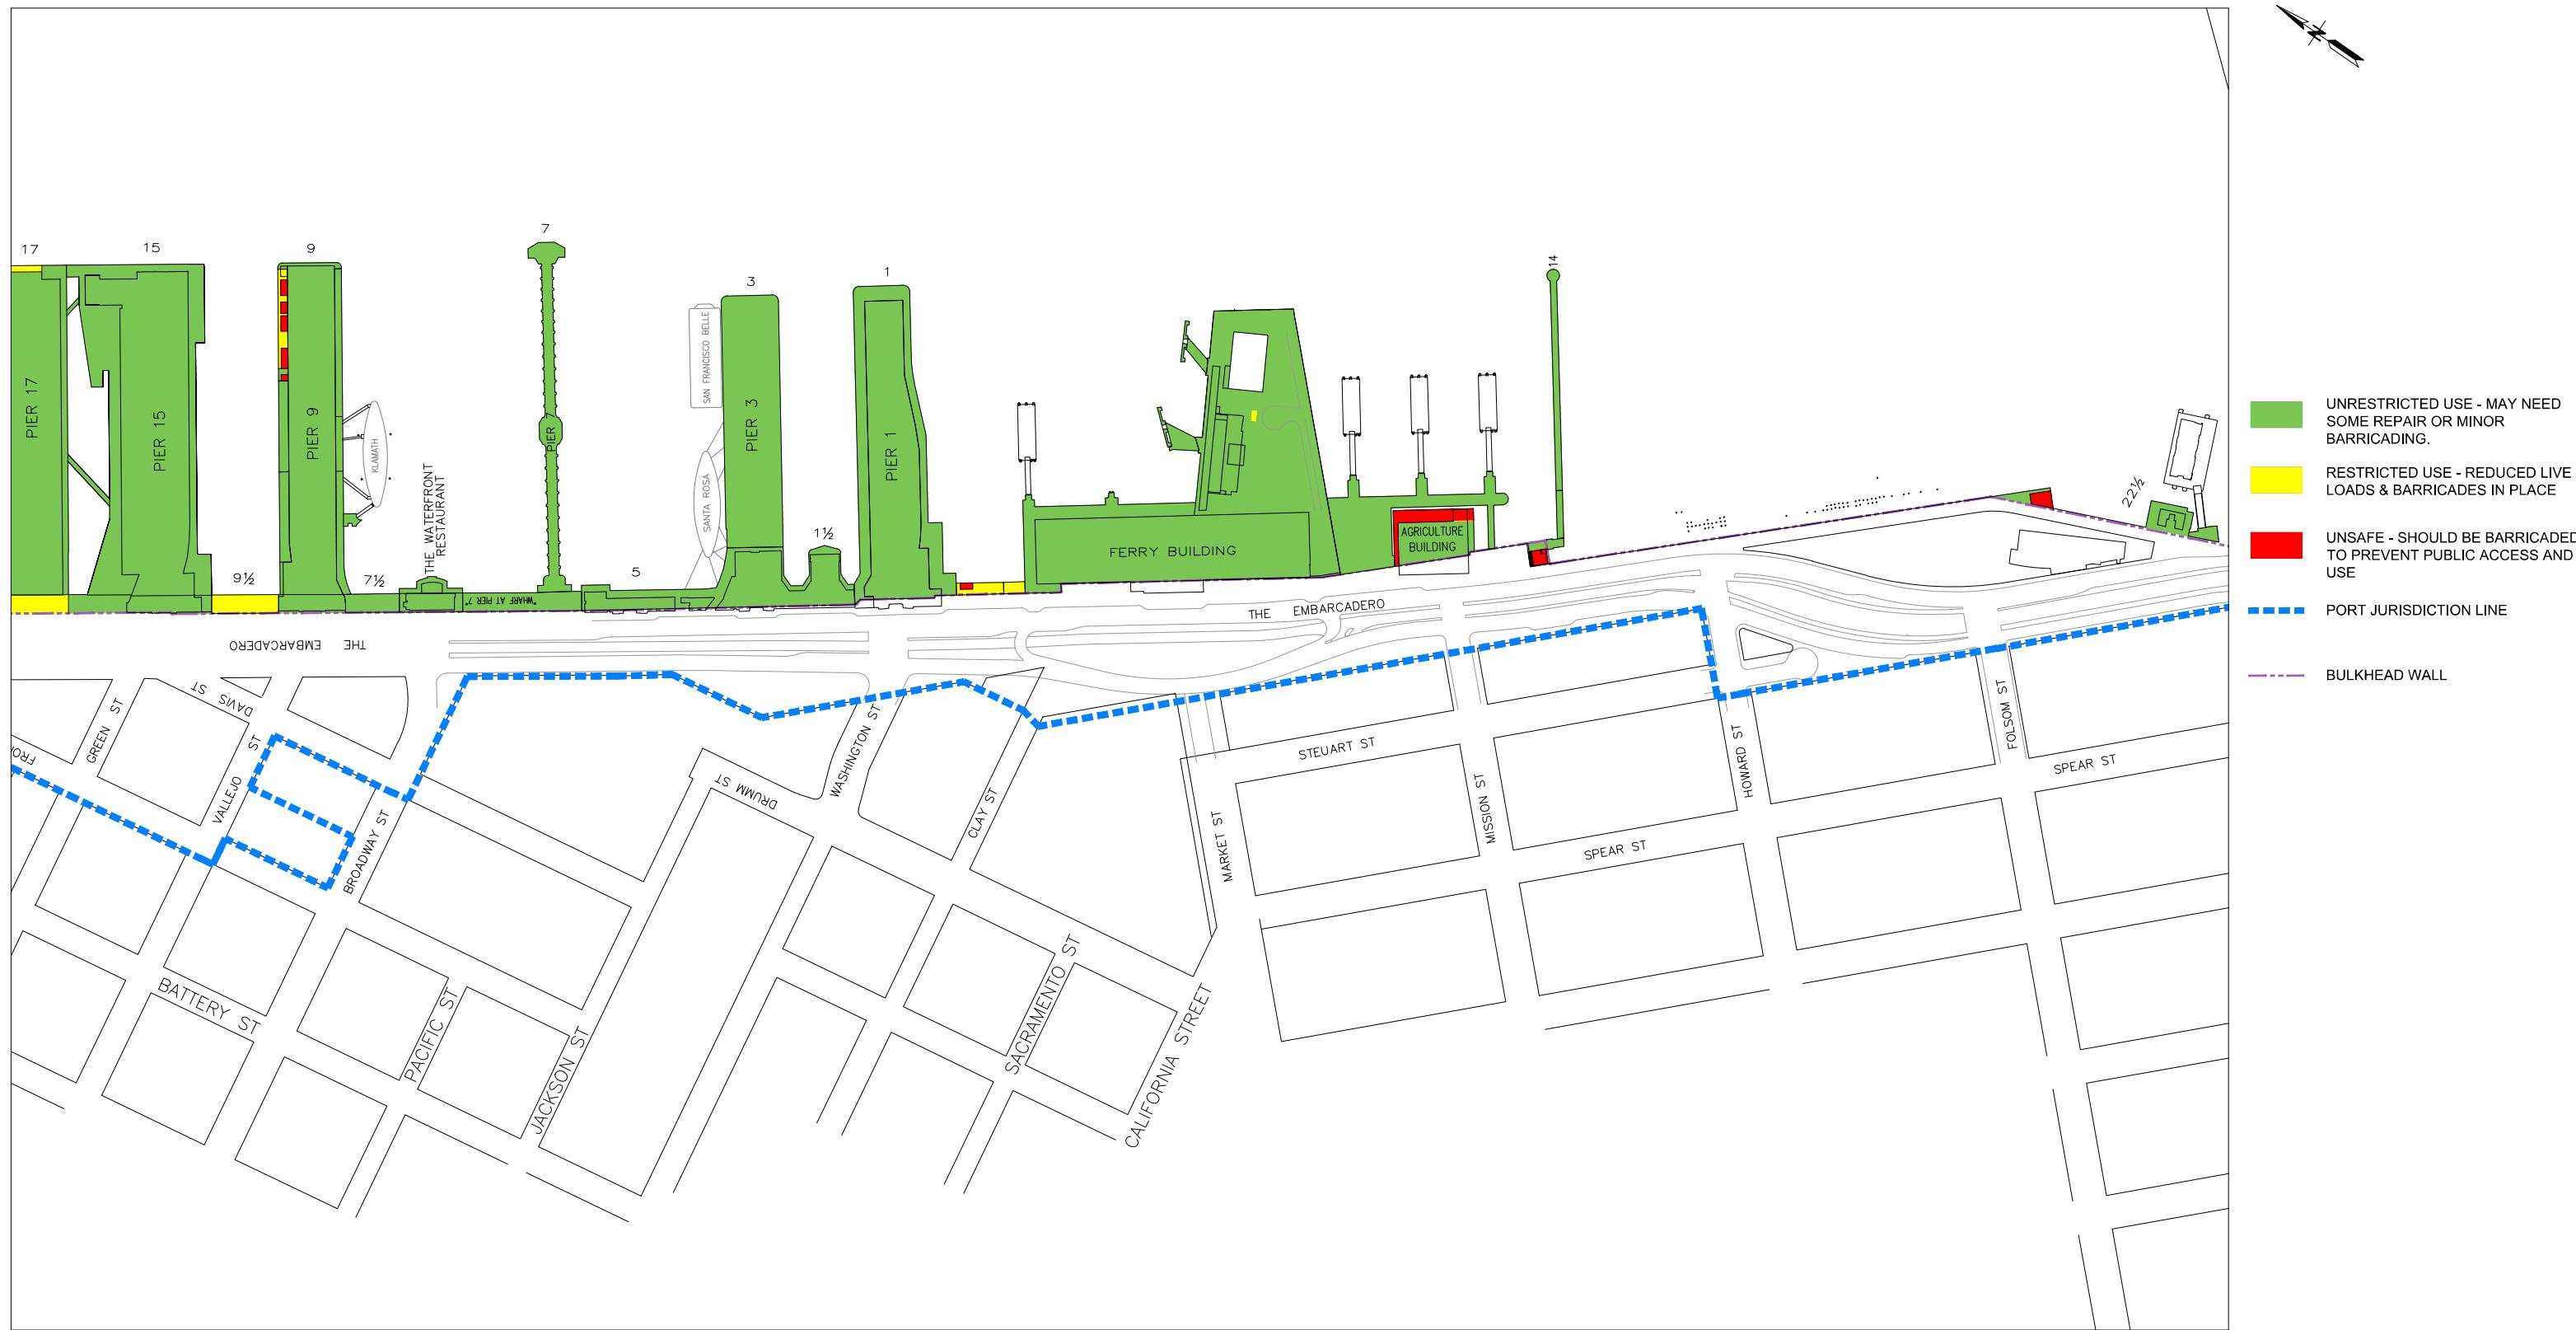
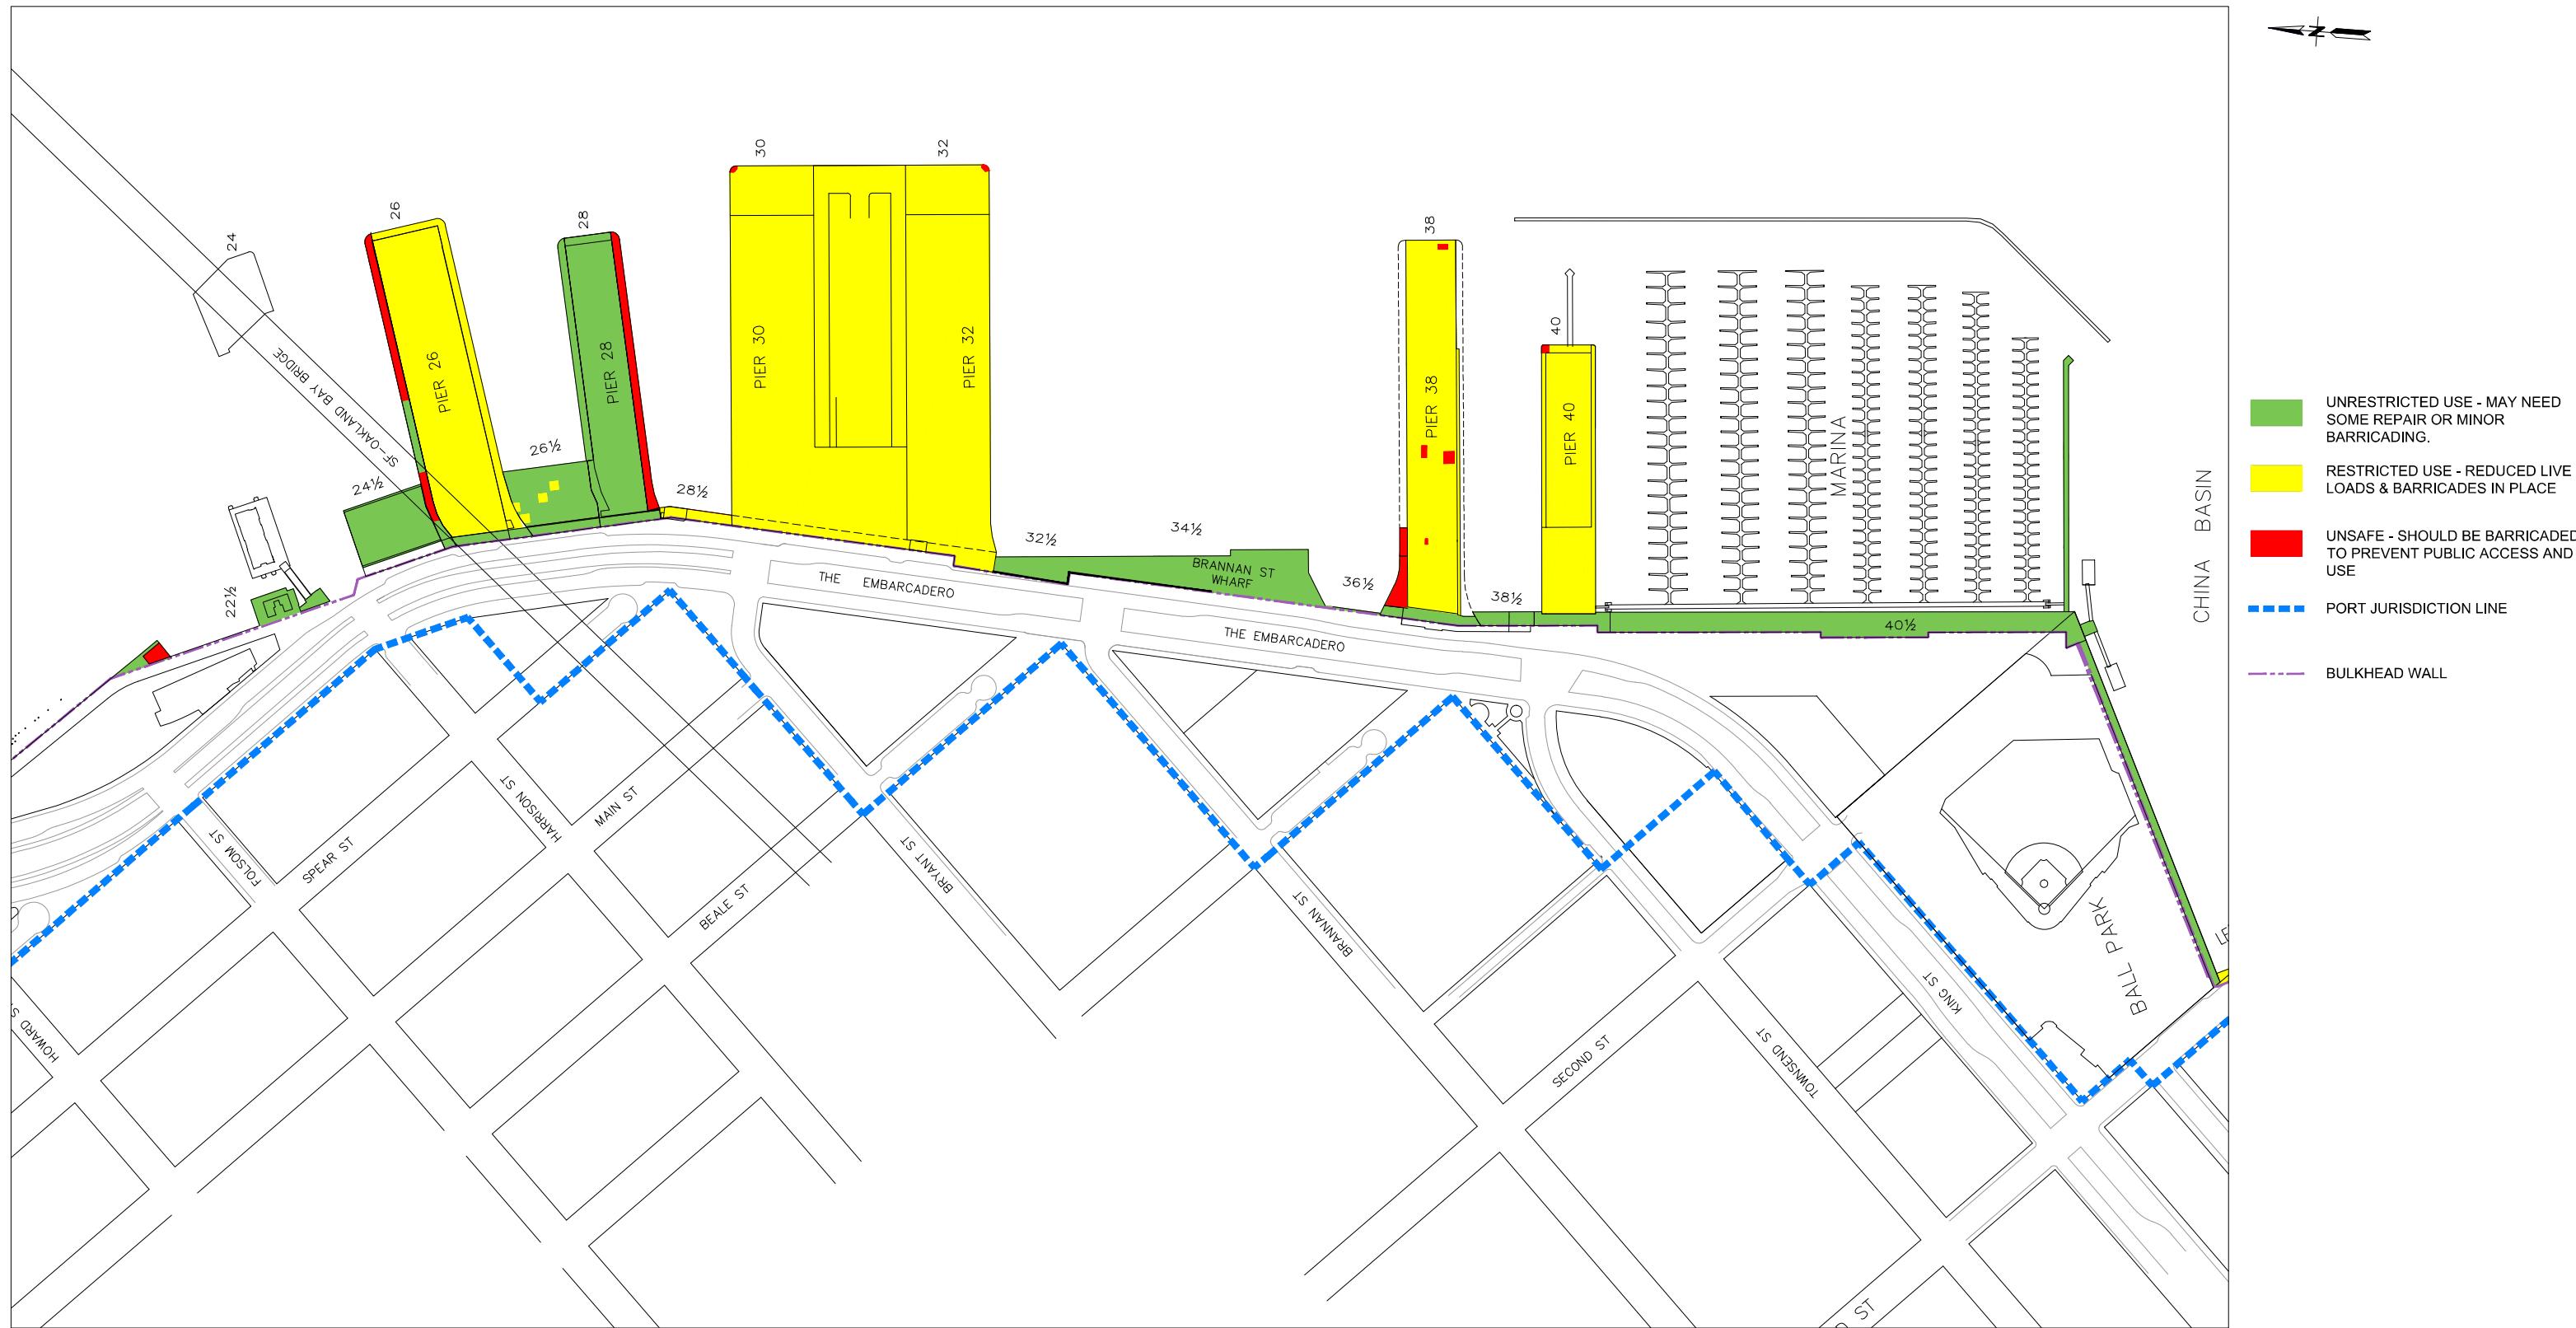
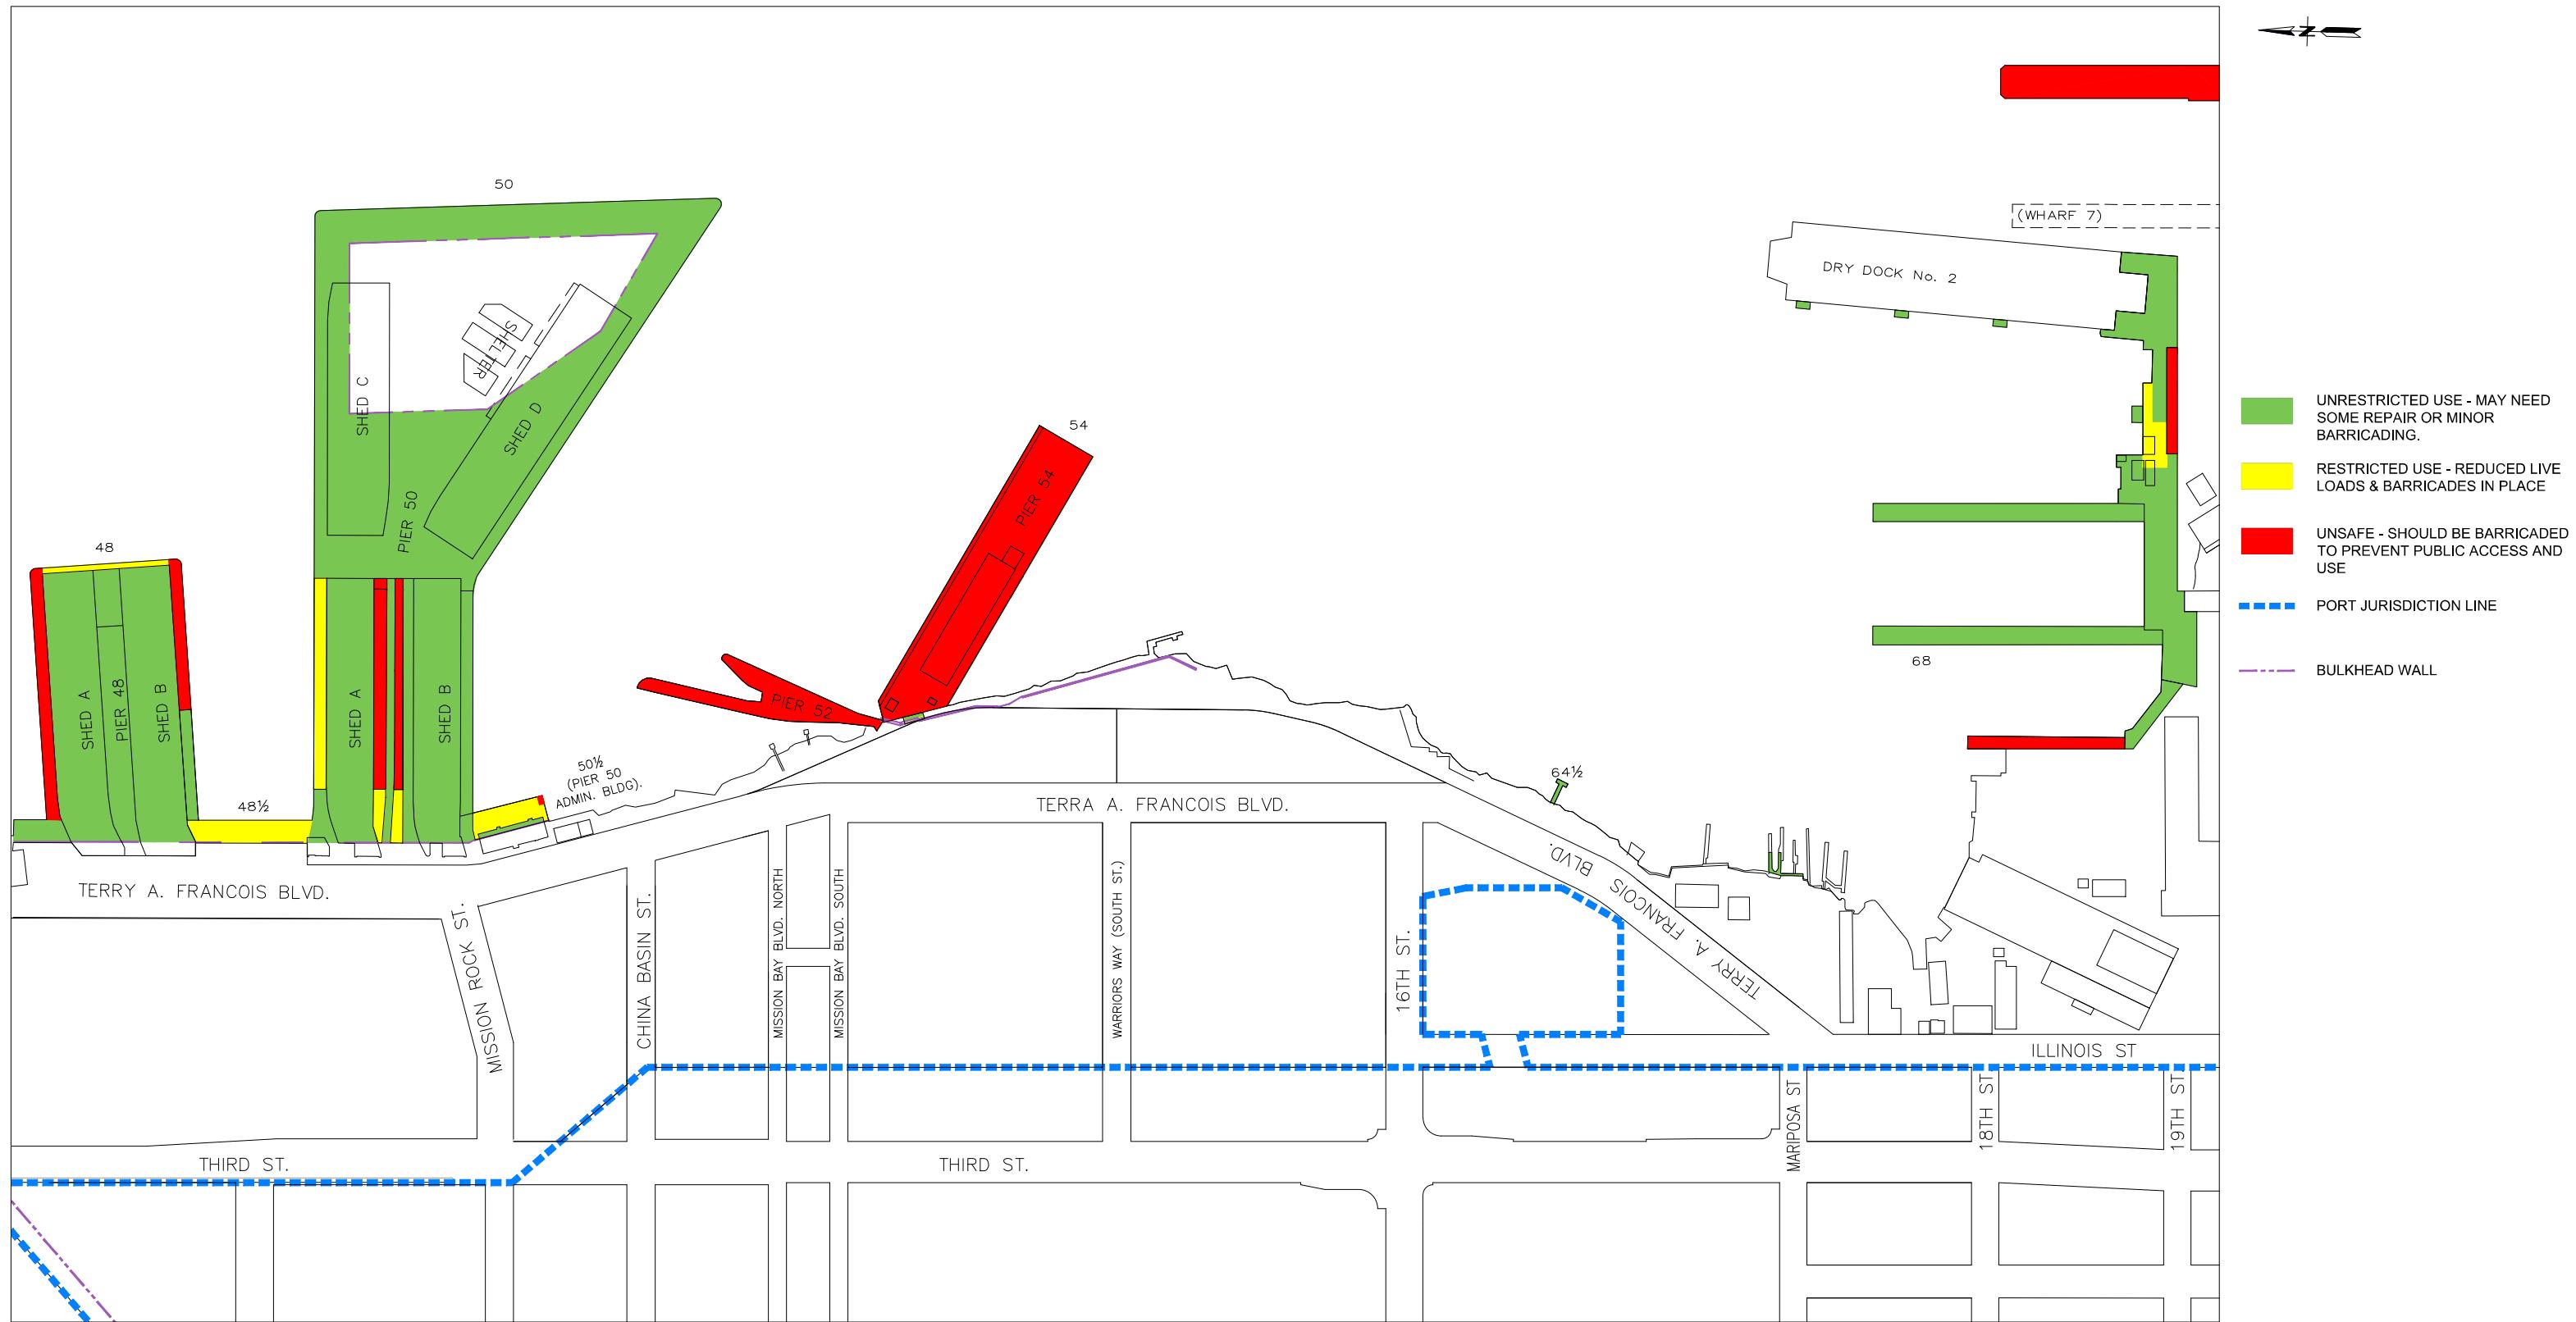
### Substructure Load Restriction Map

**Attachment 1** graphically depicts the current structural ratings of the Port substructures as of the date of this report.

The *Green-Yellow-Red* rating system communicates the current operational limitations for each substructure, with the findings valid until the date of the next recommended re-inspection.
