## MEMORANDUM

**SUBJECT:** Informational presentation on the Port's Rapid Structural Assessment Program.

### EXECUTIVE SUMMARY

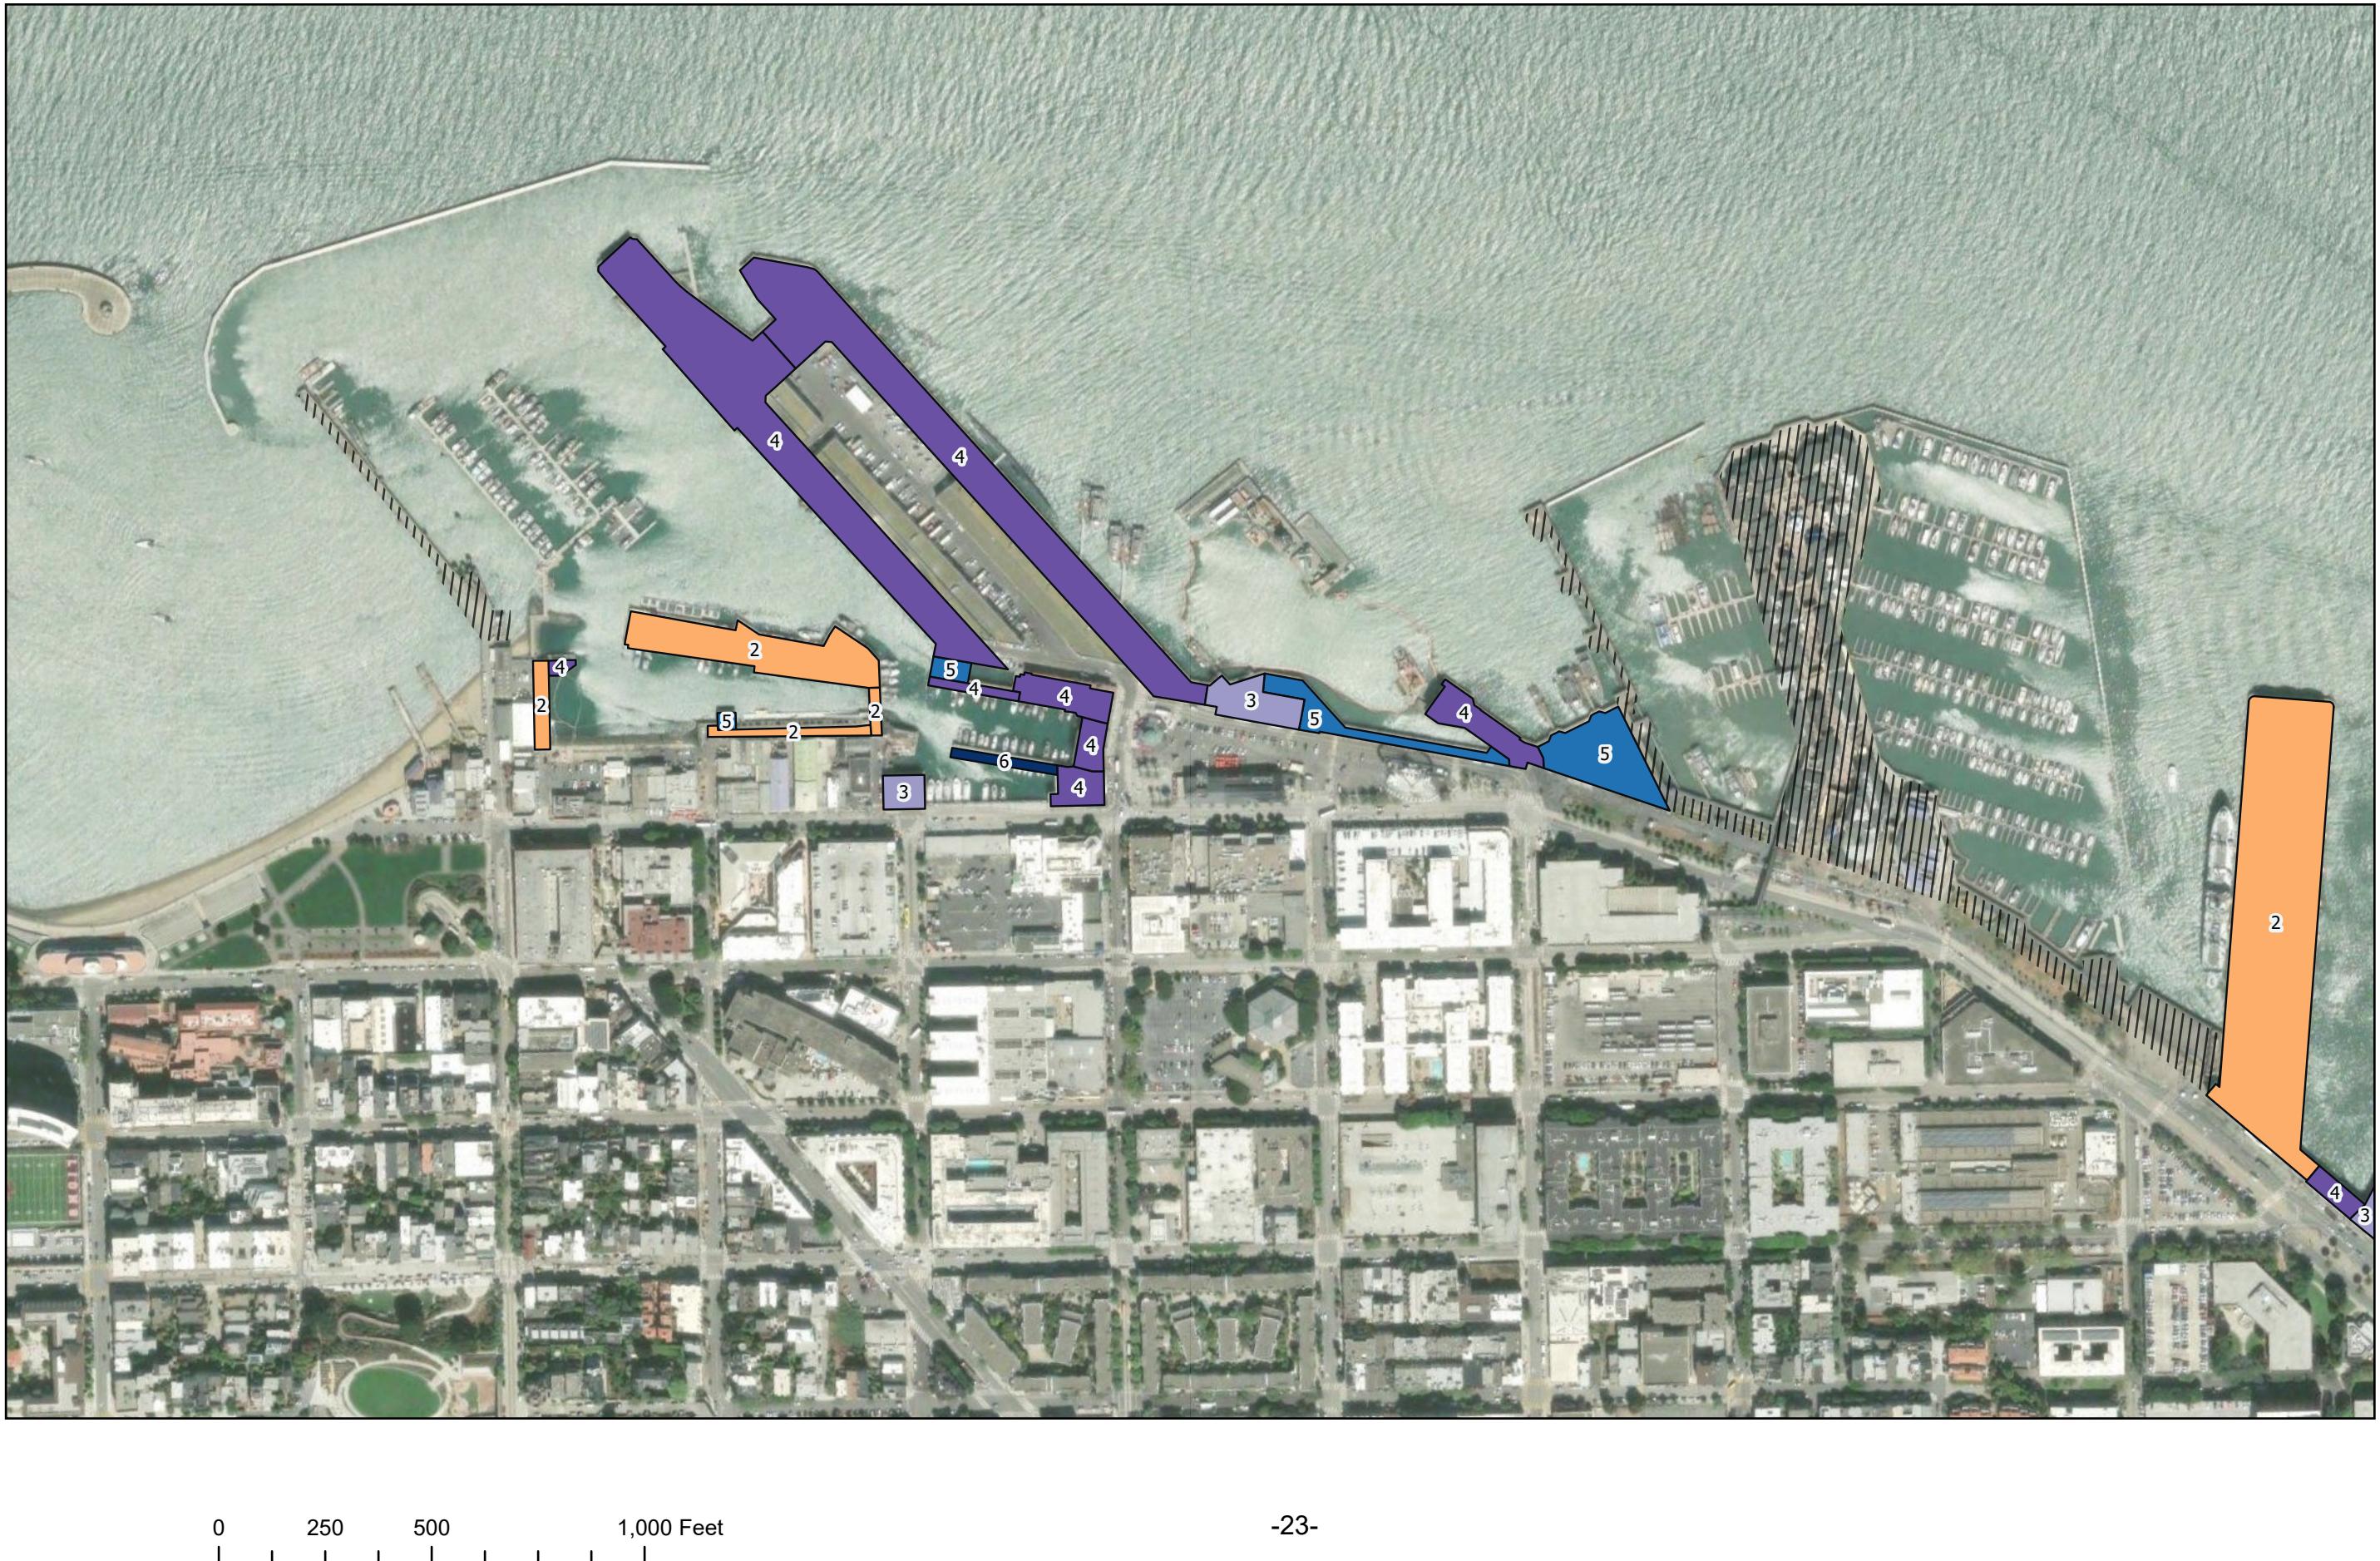
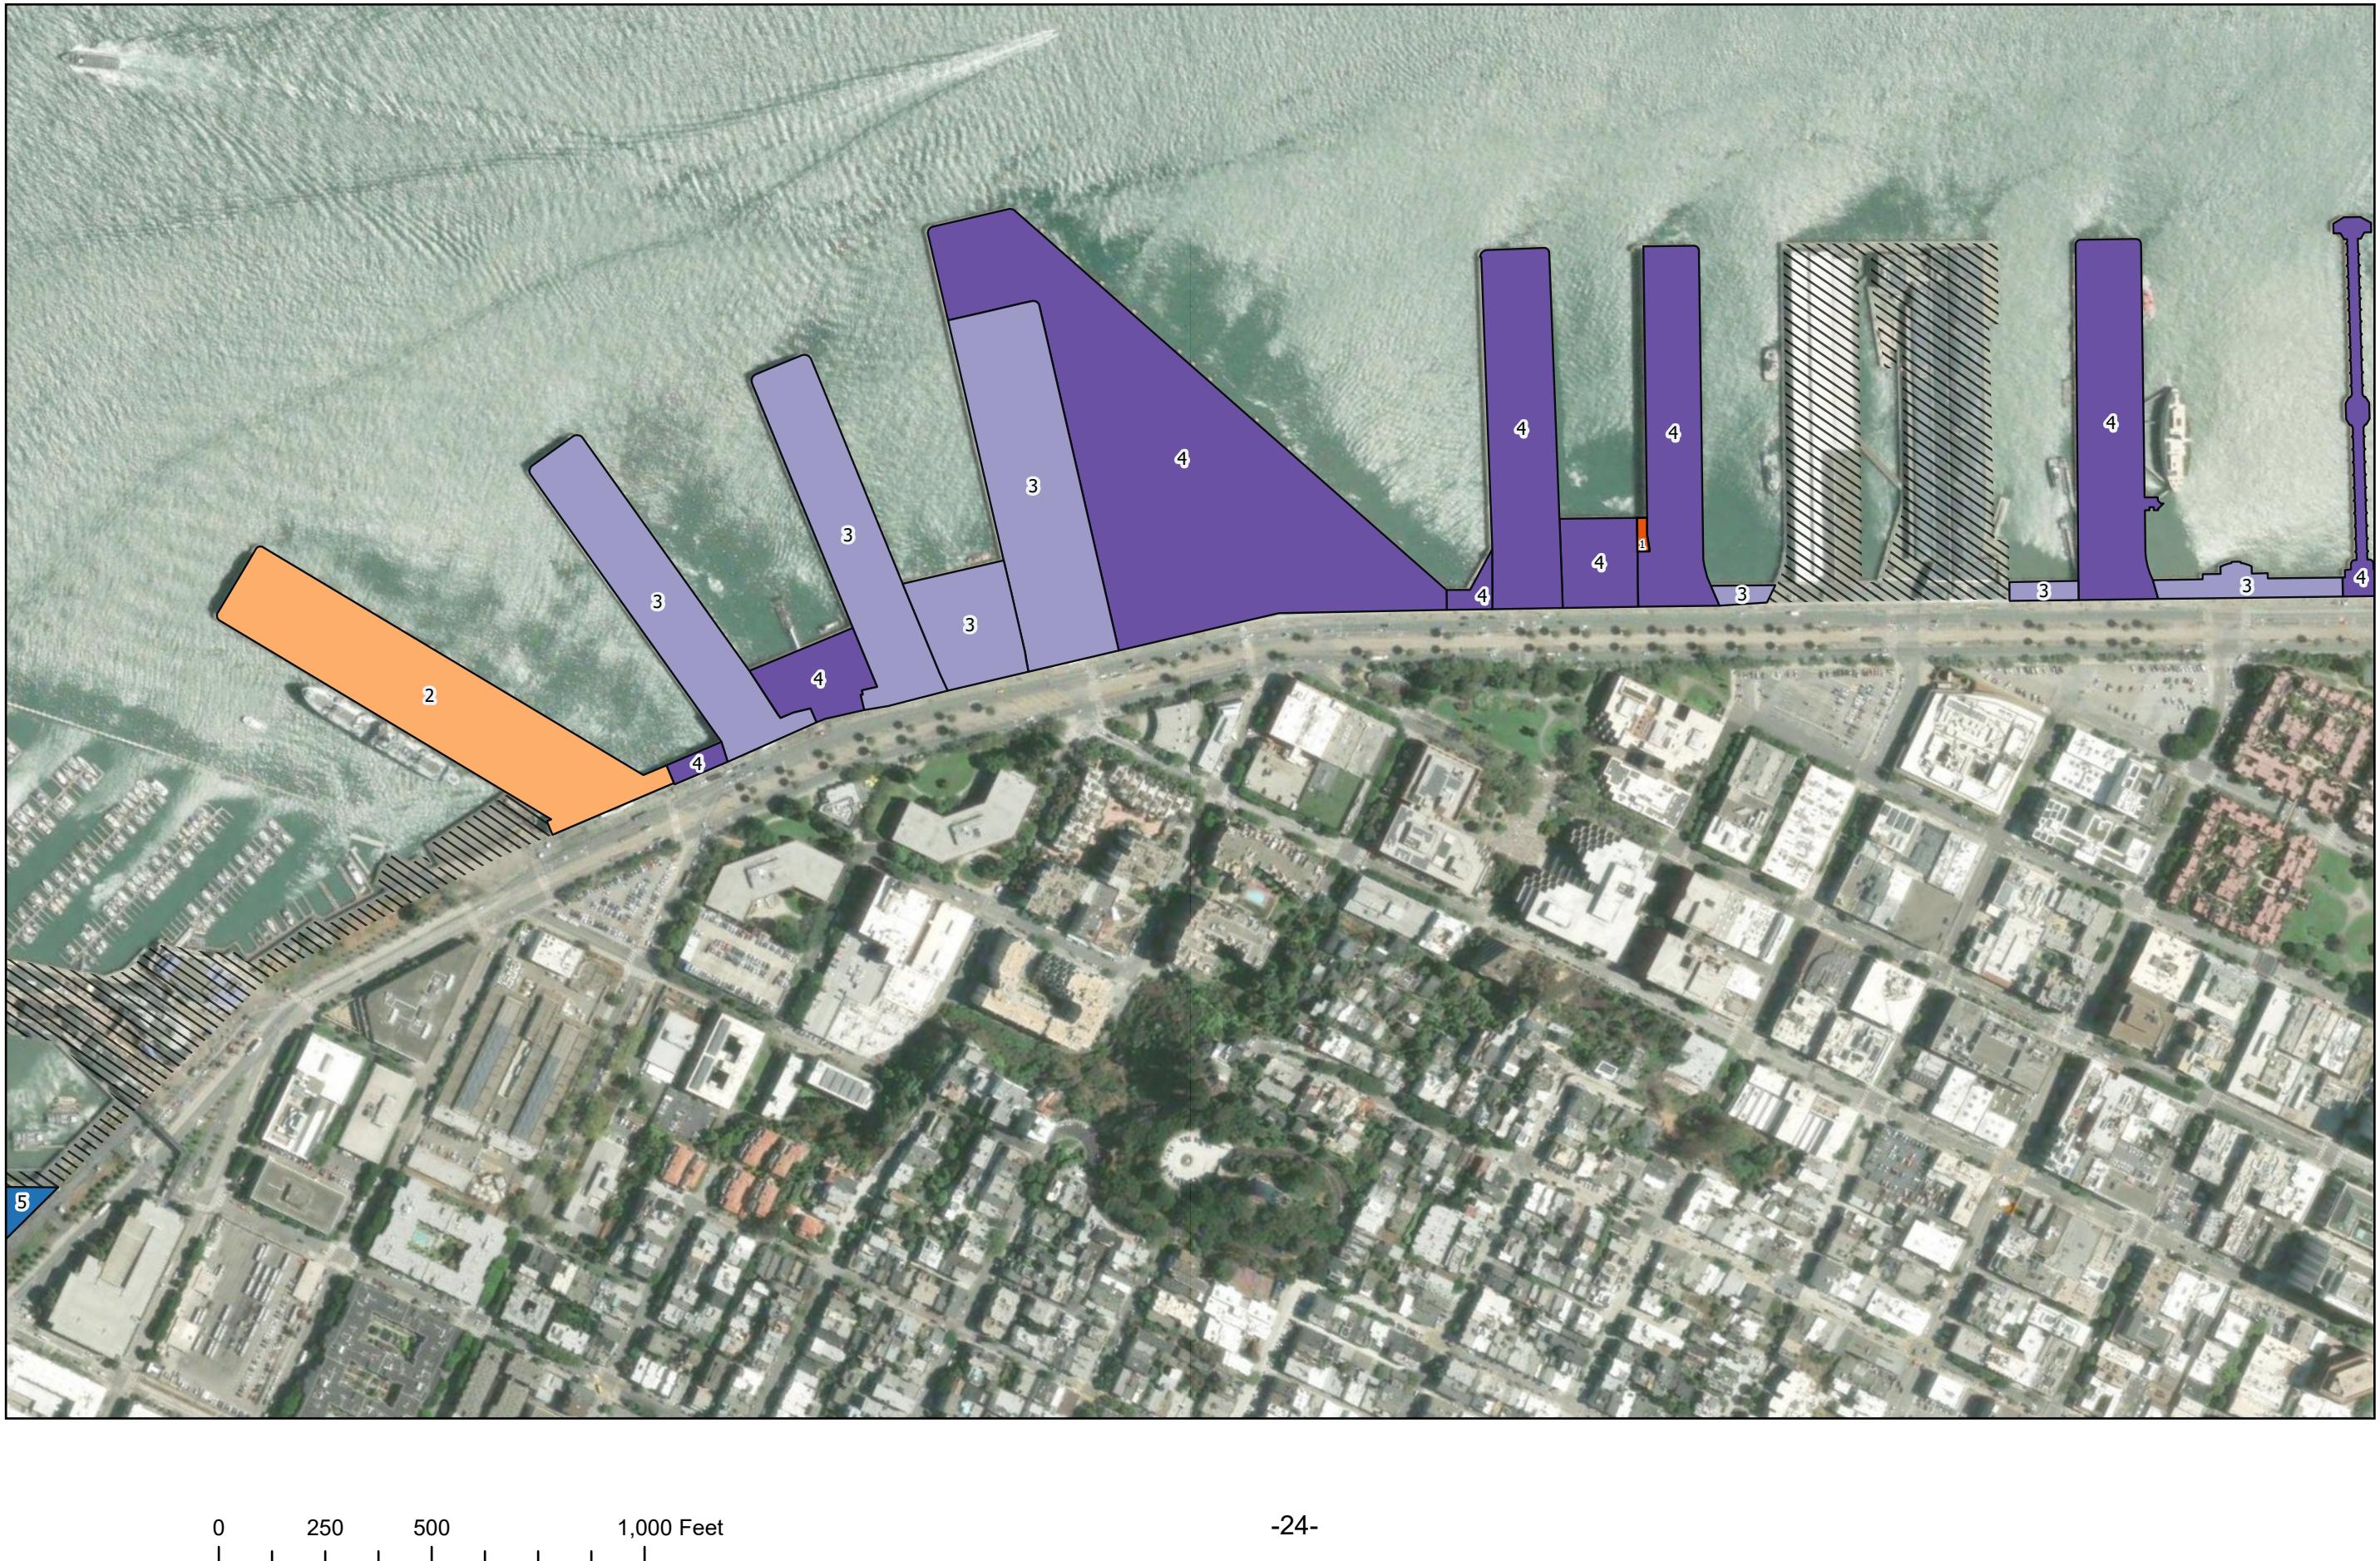
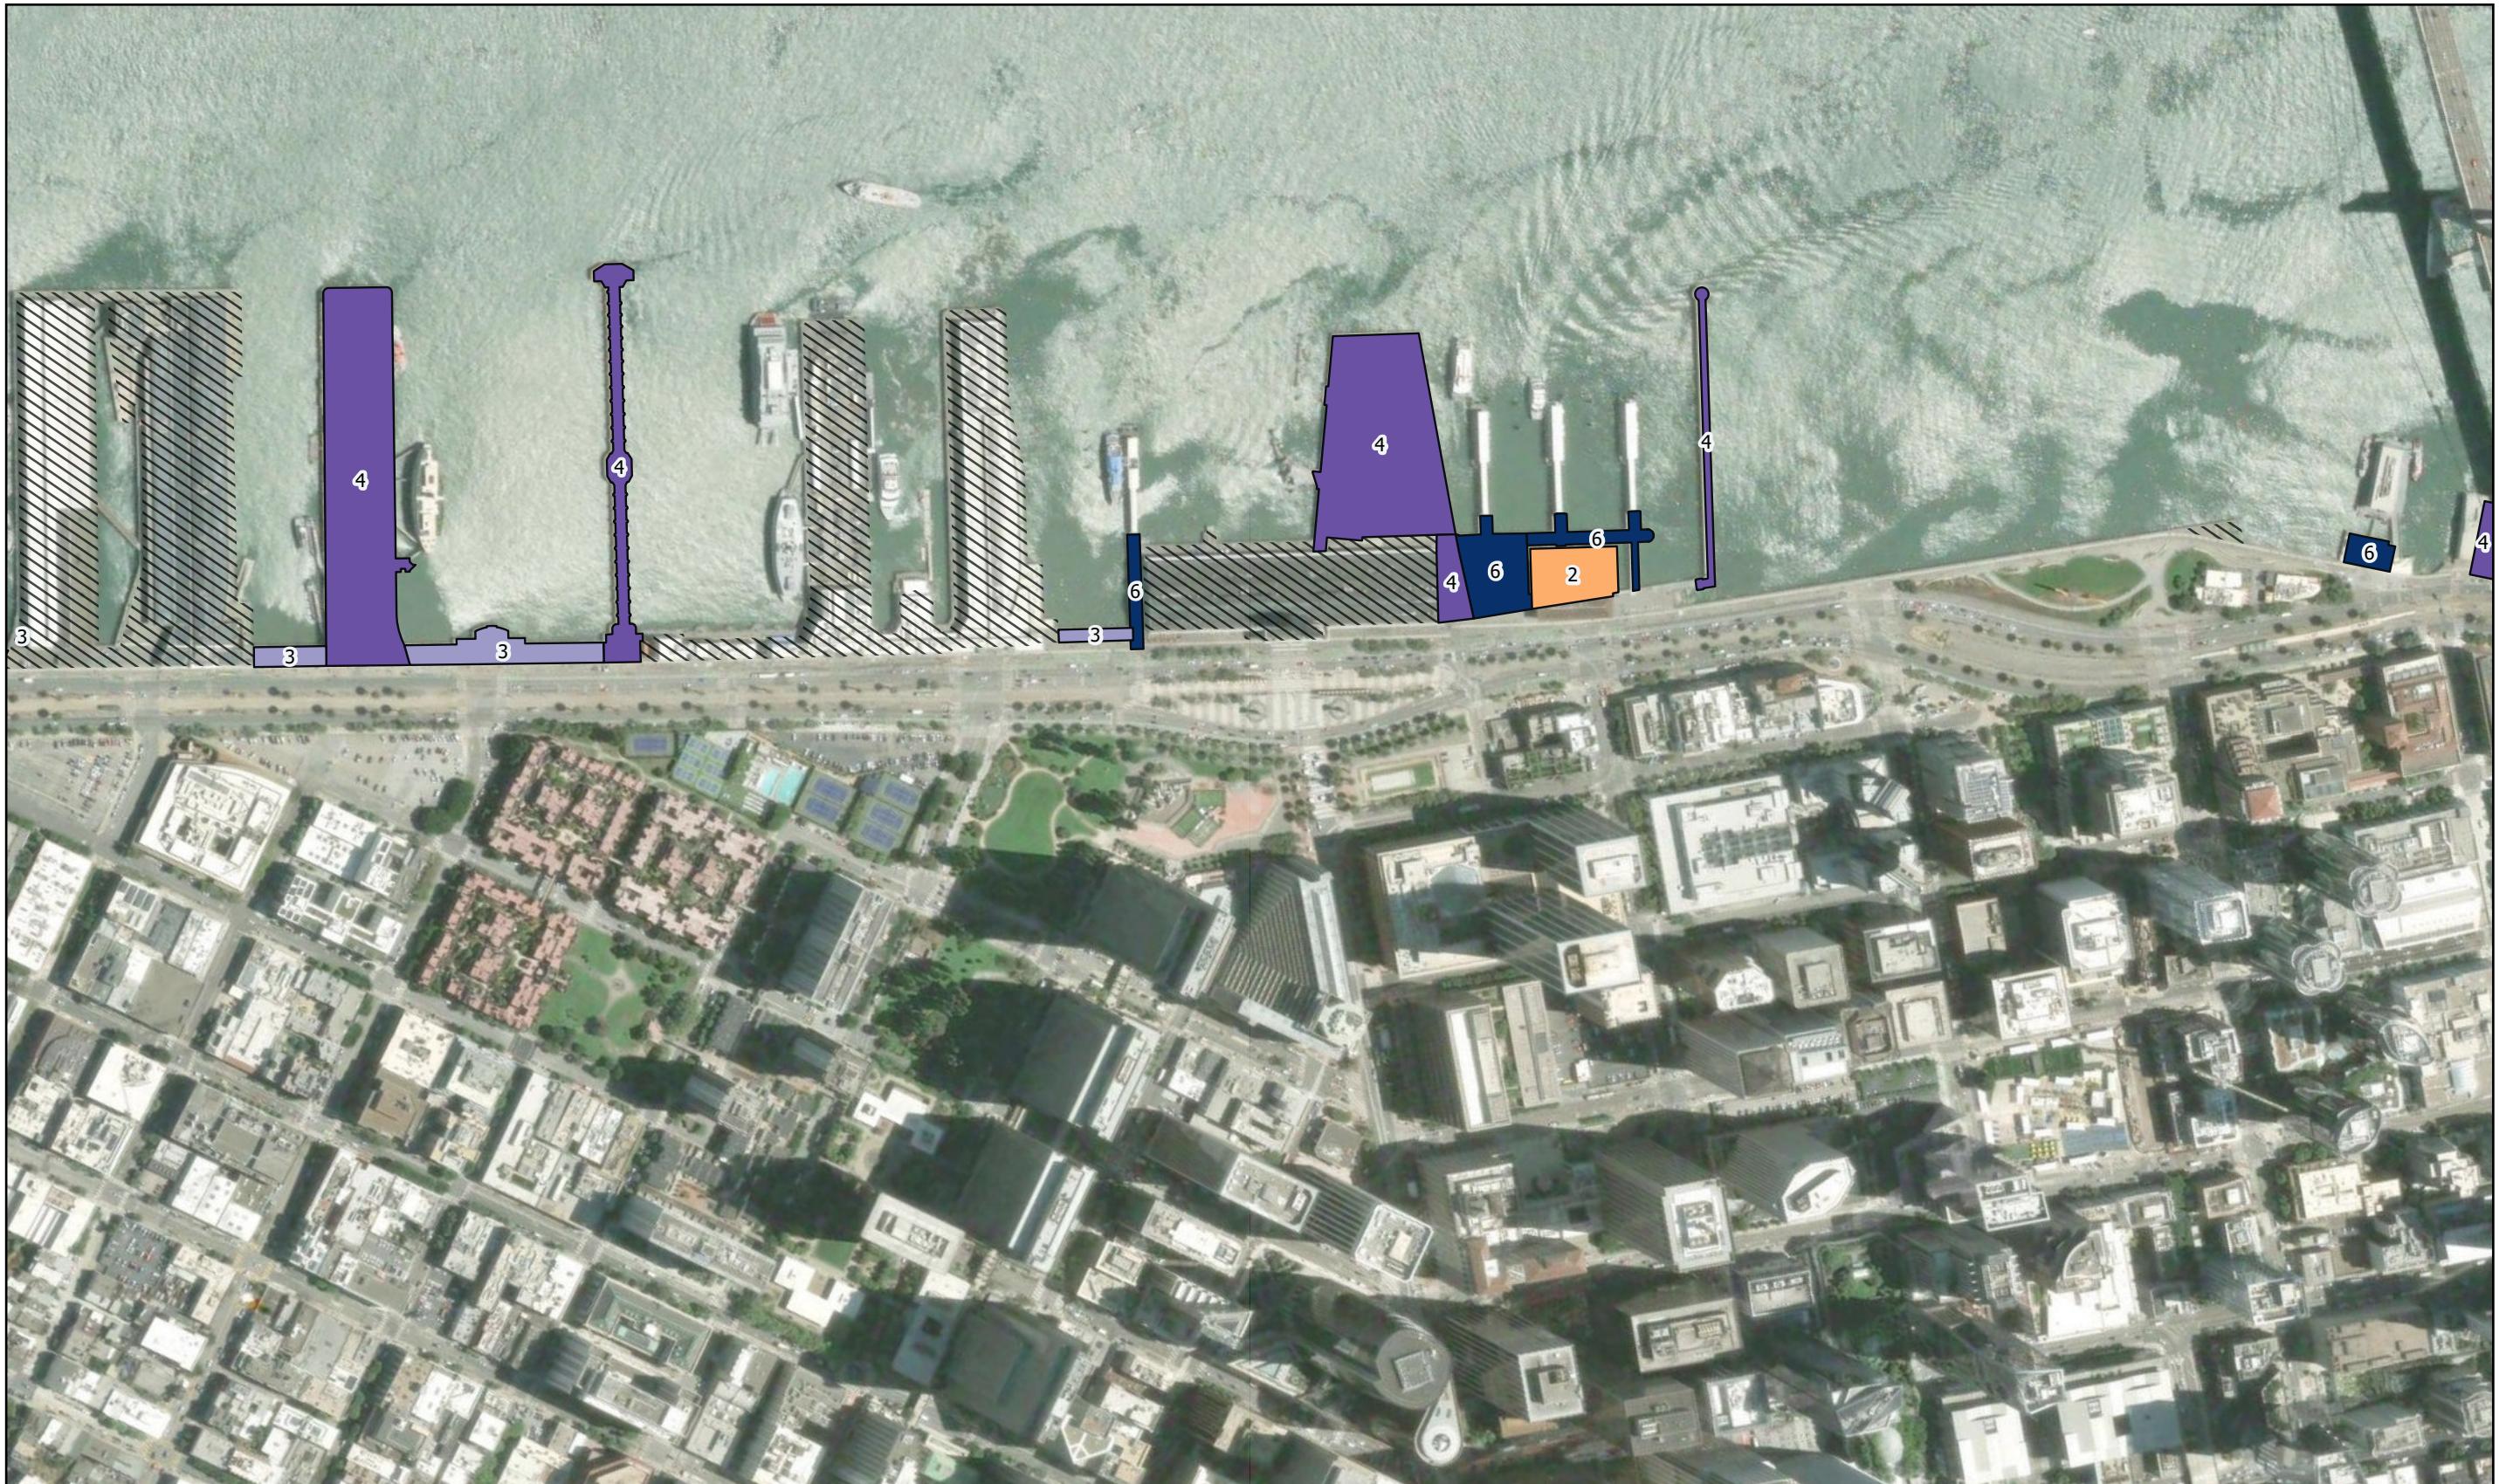
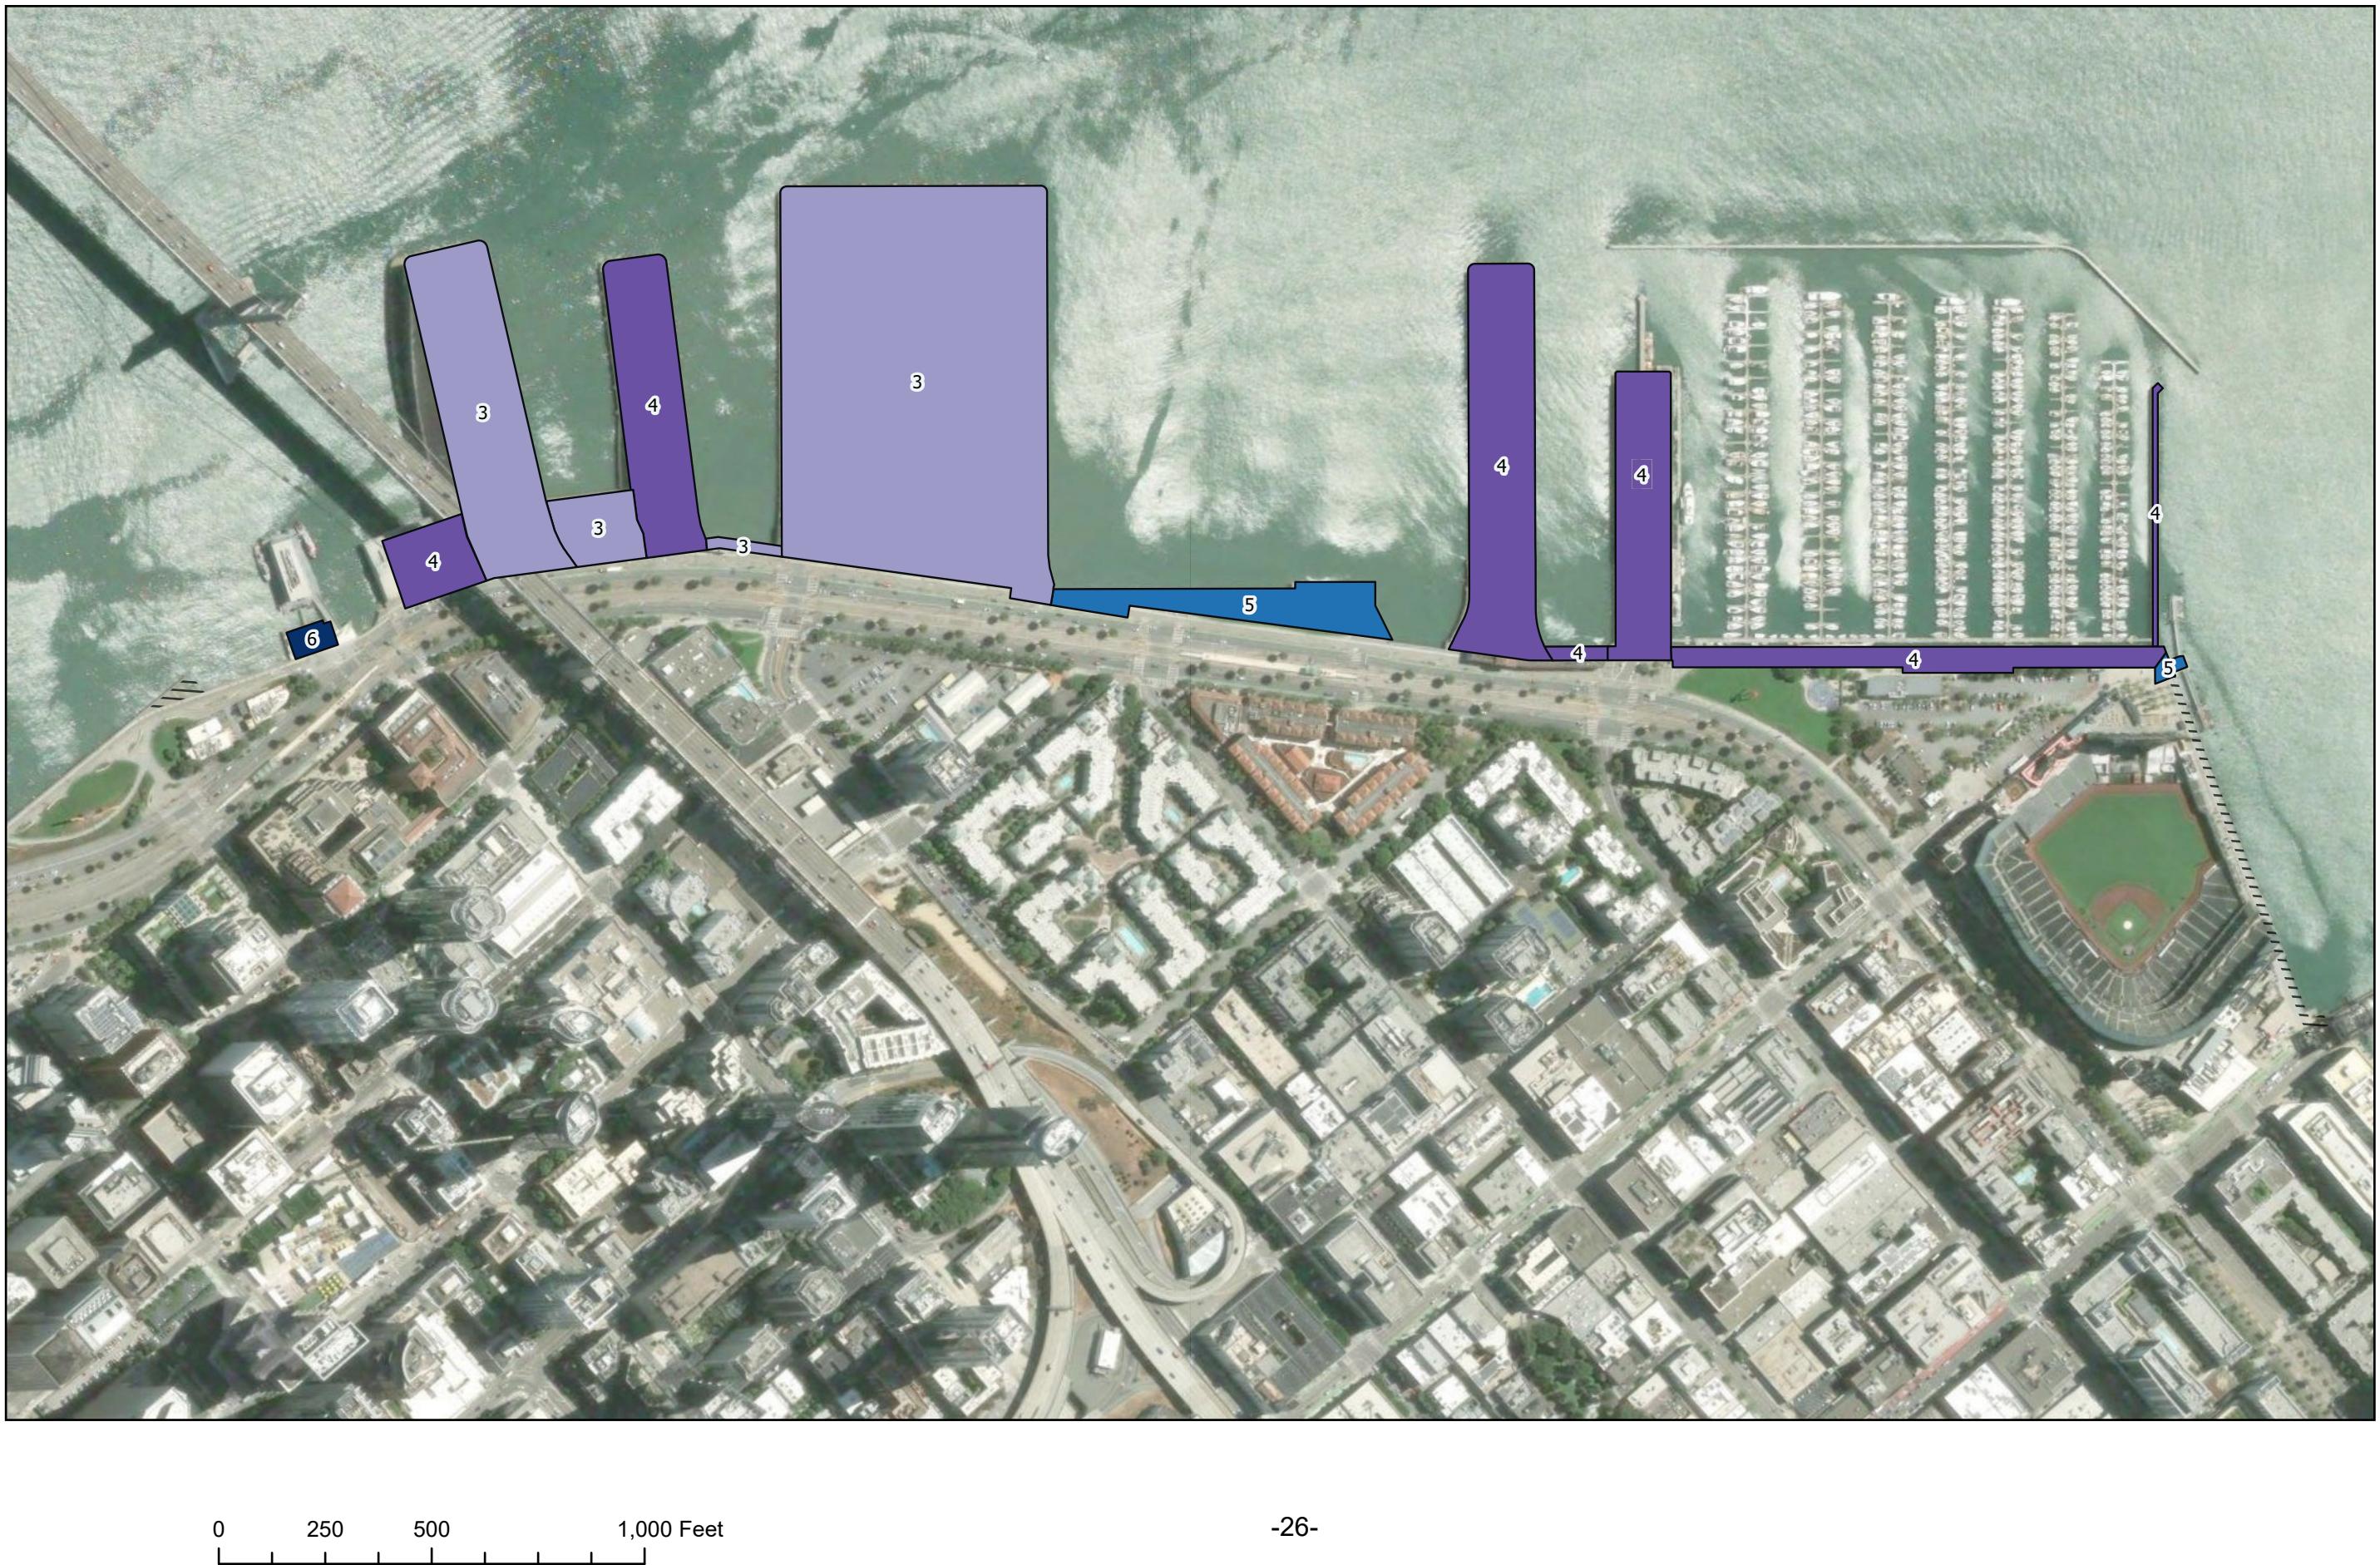
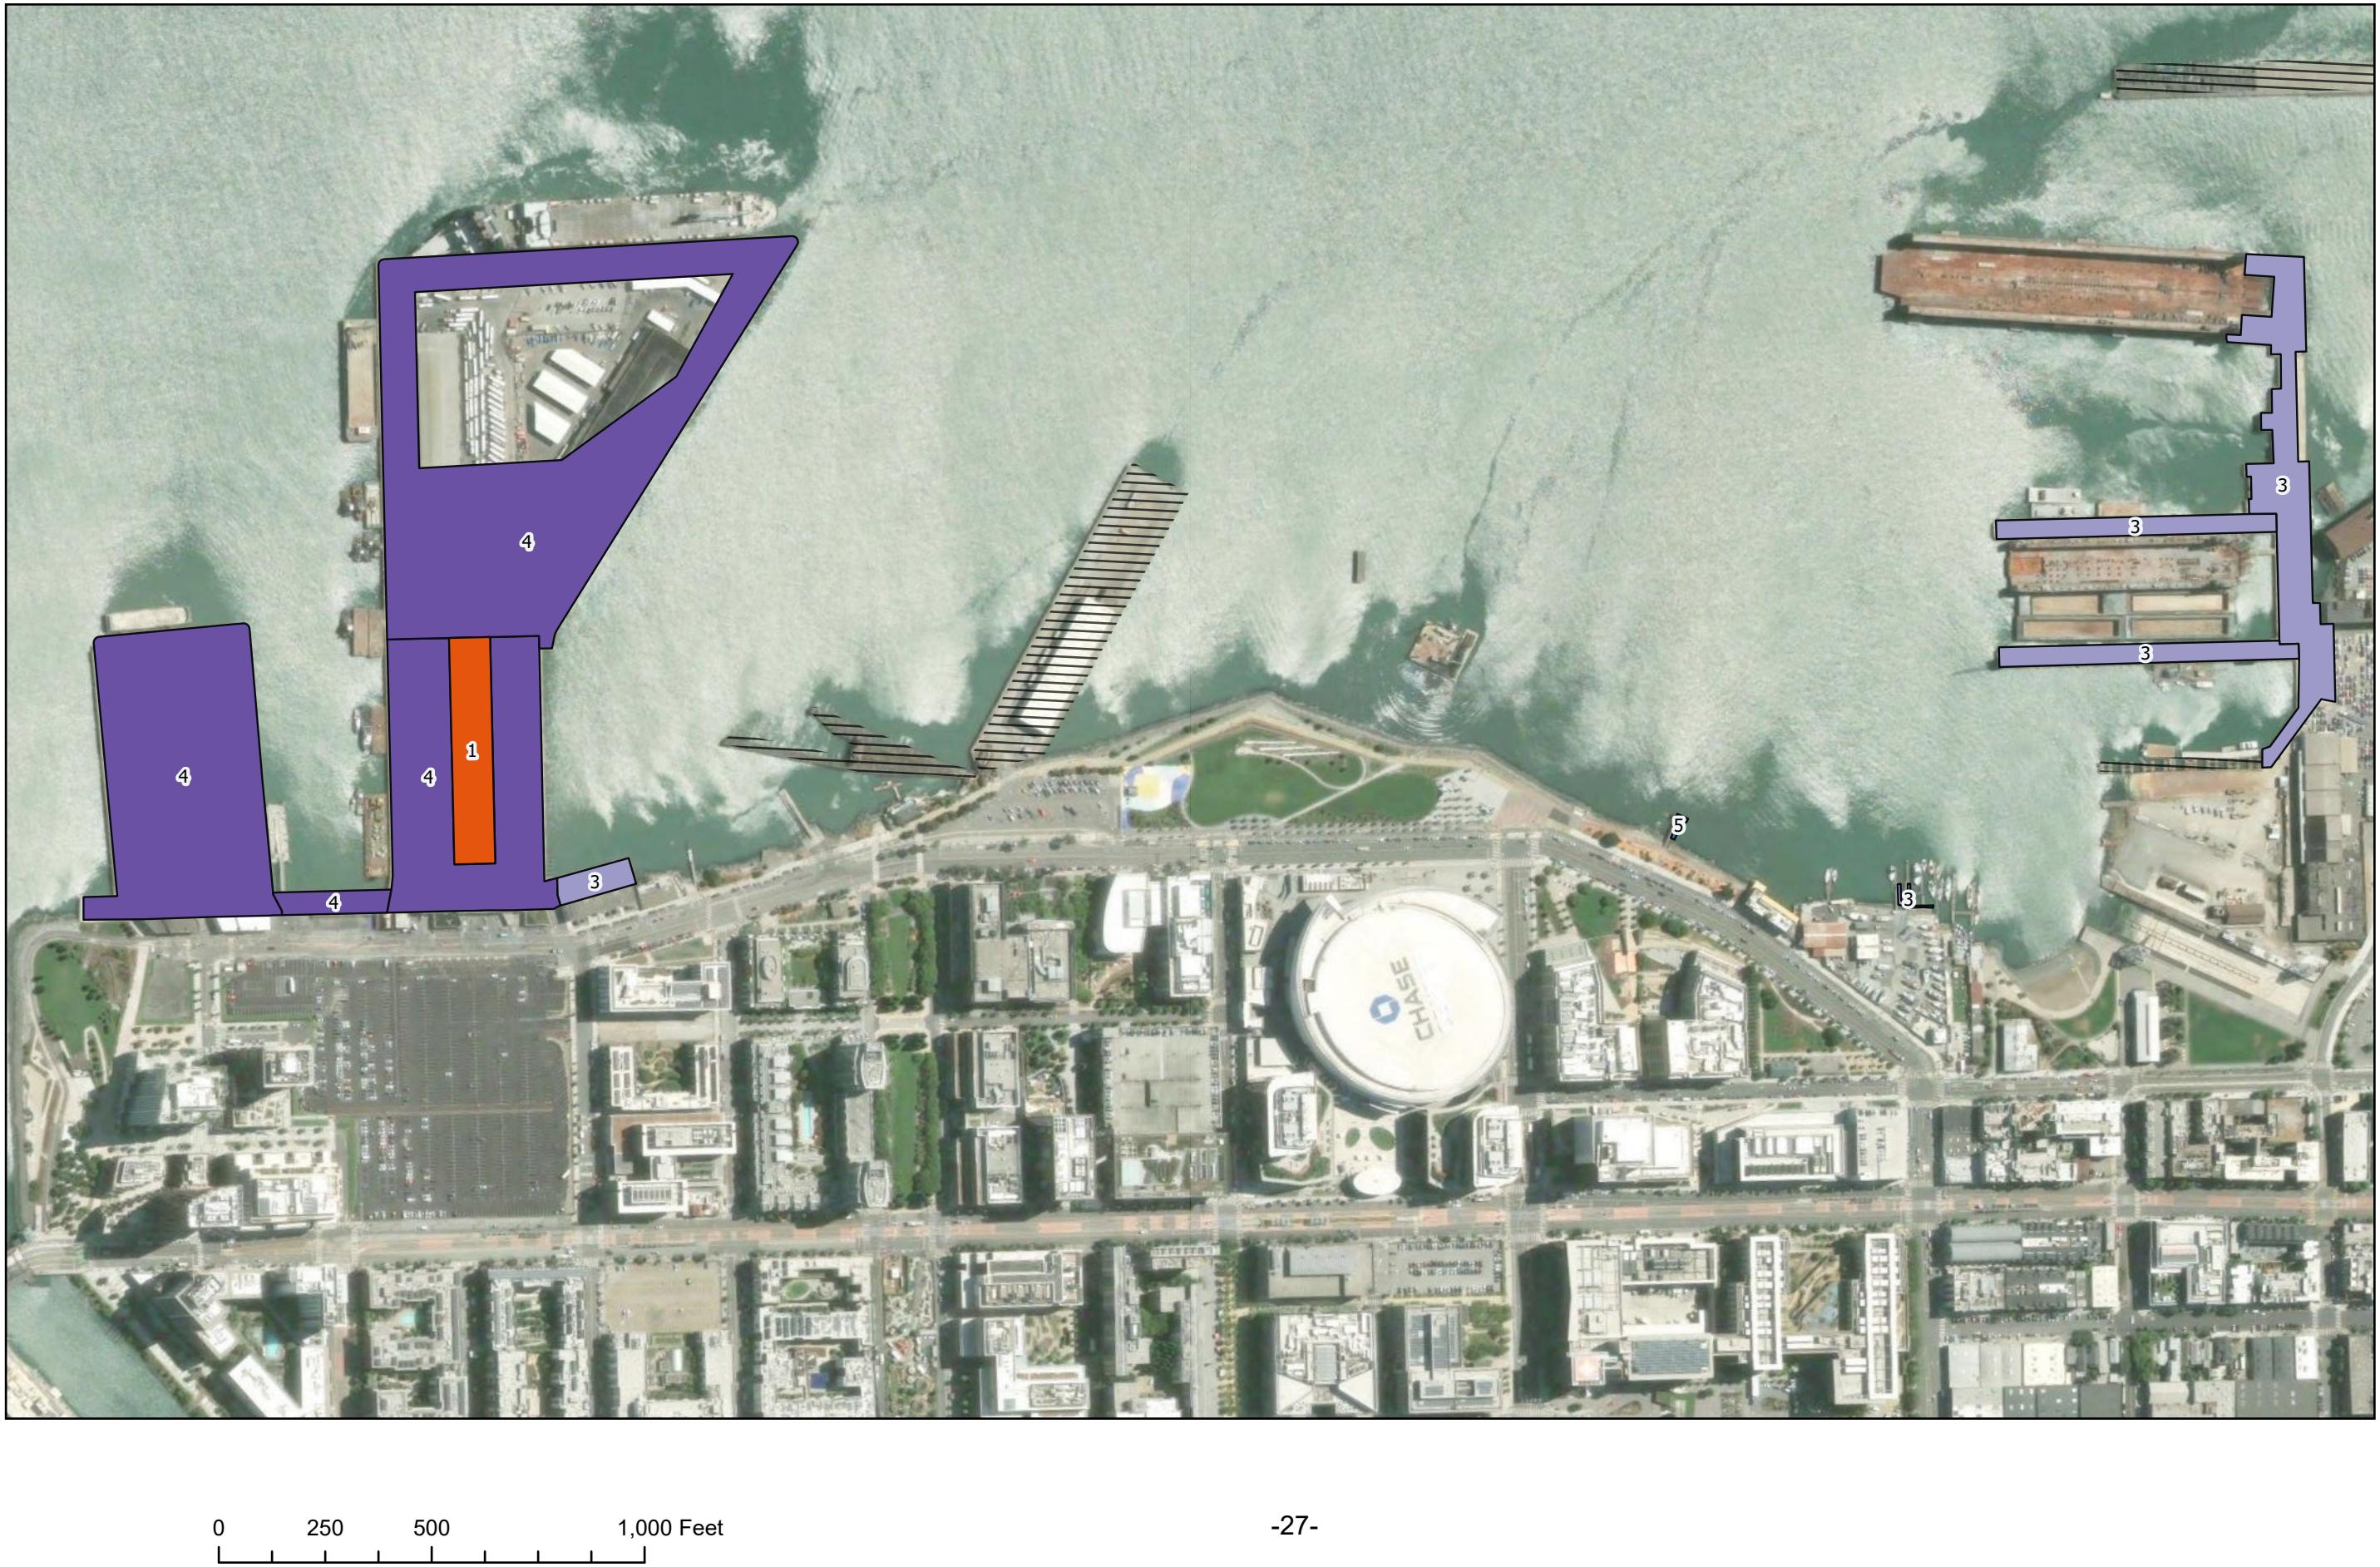
### Substructure Overall System Rating Map

The average Port-managed substructure falls between 4 *Fair* and 3 *Poor*, with minor variation between different geographic sub-areas. The differences in sub-area ratings correlate with the average age of substructures within these sub-areas, with older marine substructures generally being in worse condition. Ratings for individual marine substructures are shown on a Port-wide map in **Attachment 2**.
