Subarea Description

Piers 94 and 96 (Subarea 4-4) includes Piers 94 and 96, a mostly industrial area located on Bay fill. In the event of a disaster, a FEMA Staging Area is located on Pier 94 and a Debris Removal Staging Area is on Pier 96. Critical infrastructure includes a dry-bulk cargo terminal, the San Francisco Bay Railroad, the Recology Recycling Center (including sustainable crushing and concrete recycling facilities) and a long term lay berth used for maritime, industrial, and emergency response services.

Subarea 4-4

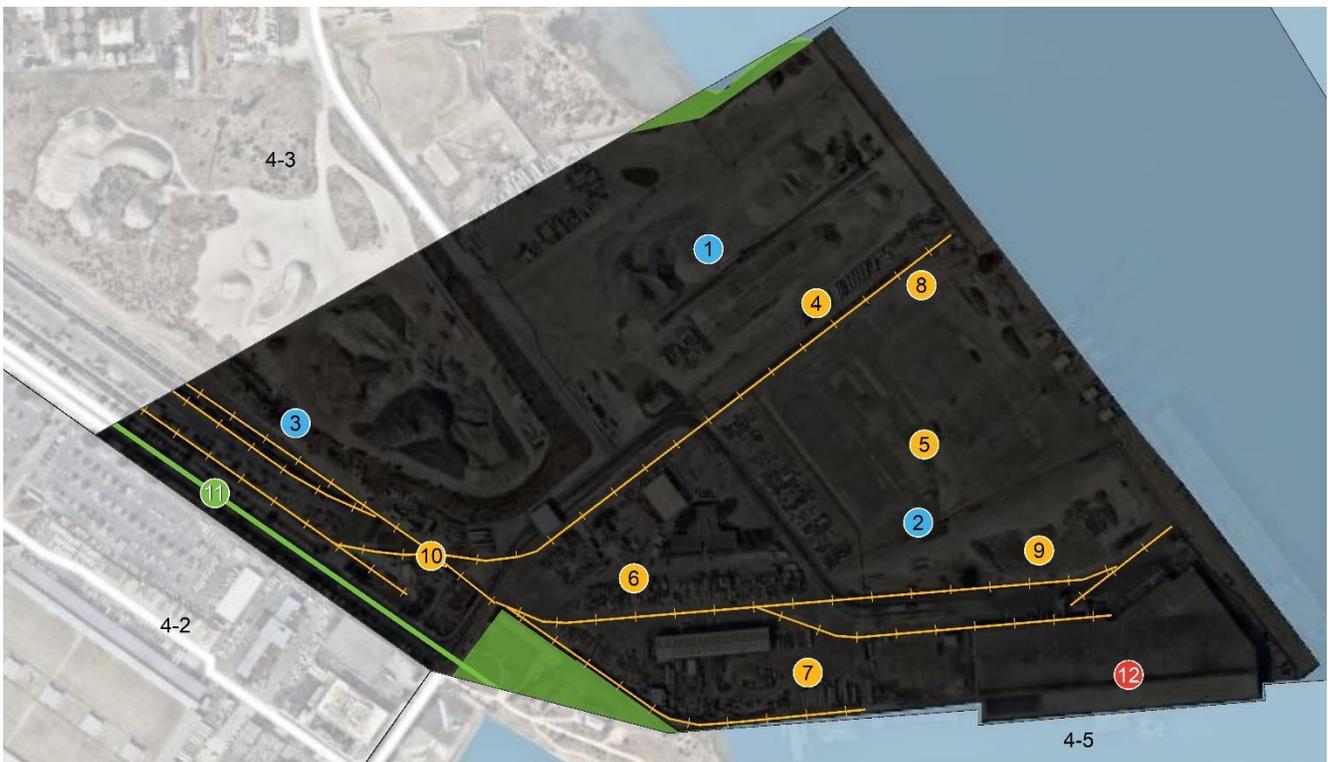
The shoreline within this subarea is primarily engineered (structures on piles) that transitions to an embankment at the boundary with Subarea 4-5.

The primary pathways of flooding are from overtopping of the southern edge of Pier 96 adjacent to Lash Lighter Basin, and eventually overtopping of the shoreline at Pier 94 adjacent to the Pier 94 Wetlands. Eventually inundation of this subarea connects with all adjacent subareas (Subareas 4-2, 4-3, and 4-5).

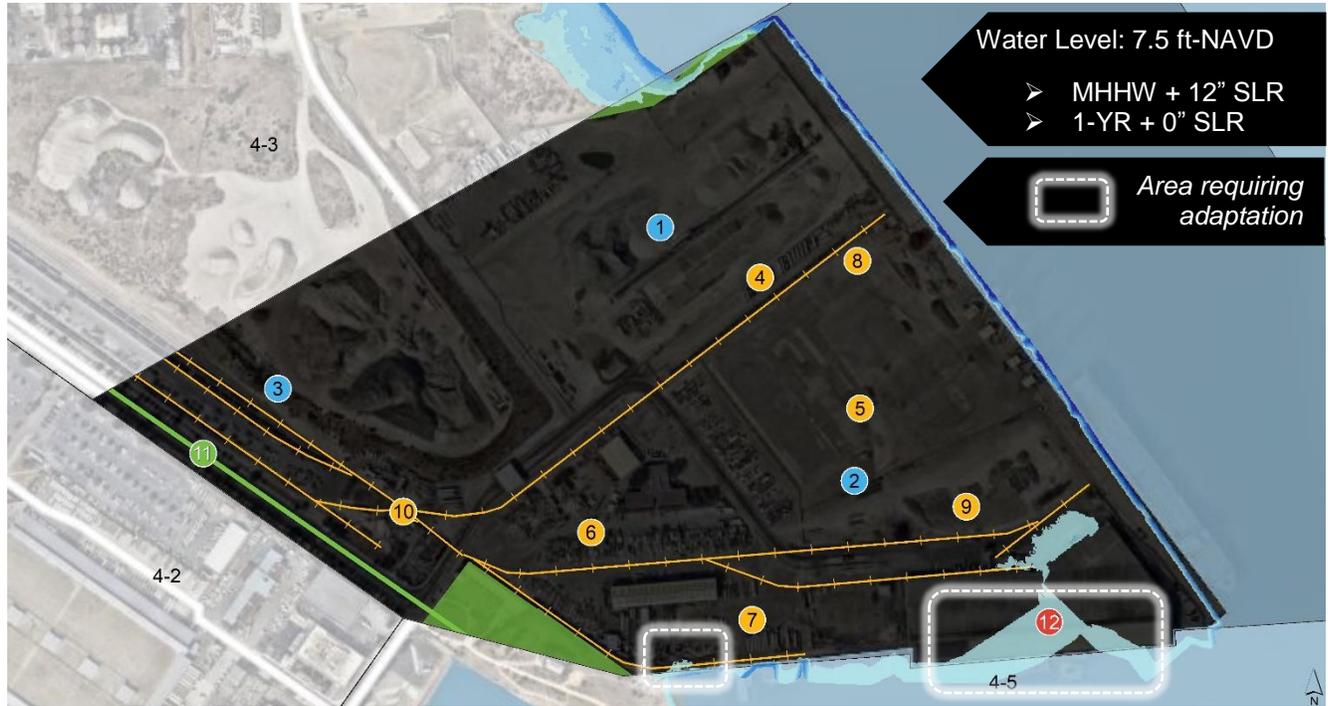
Adaptation Focus: Immediate

Shoreline Characteristics	Shoreline Overtopping					Timing of Impact (100-YR)					
	Classification	Avg. Elev.	Avg. Depth (ft)	Max Depth (ft)	Length (ft)	%	USACE Low	USACE Inter.	OPC Most Likely	USACE High	OPC 1-in-200
Engineered	7.0 ft. NAVD	0.5	1.1	599	11.5%	Today	Today	Today	Today	Today	Today

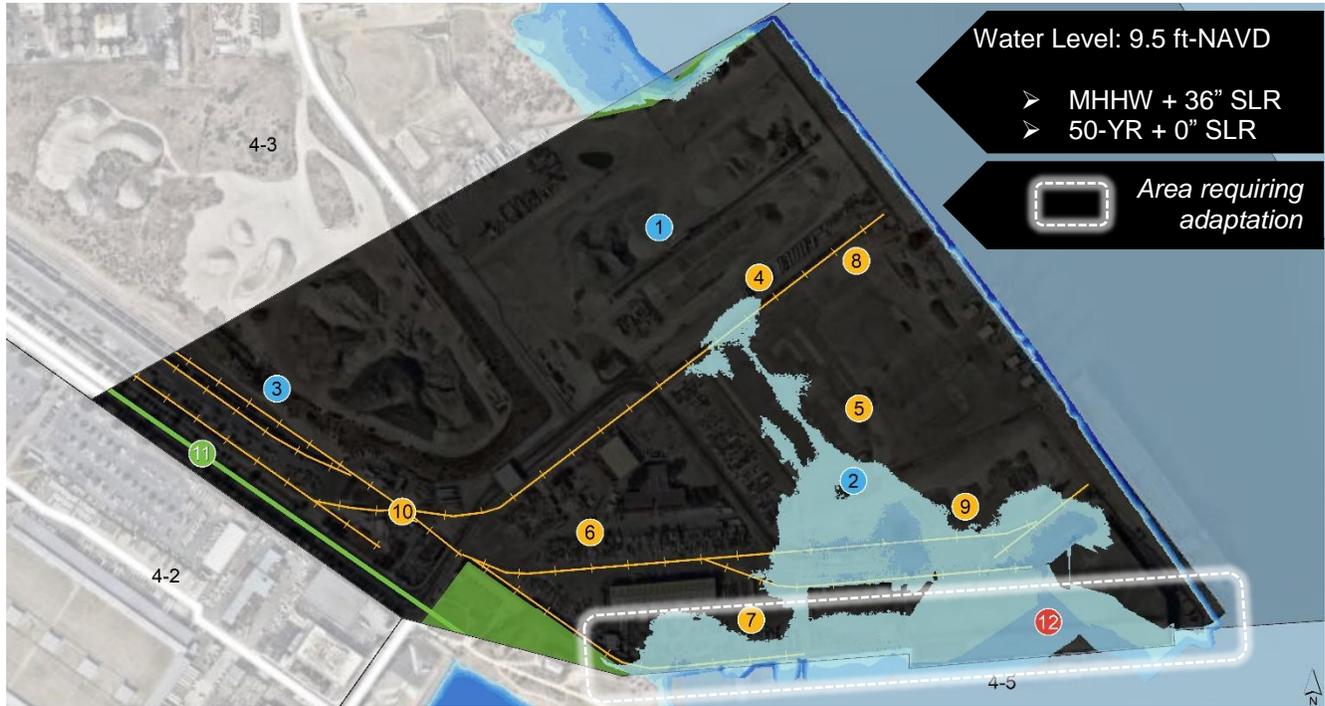
Adaptation Focus: Tipping Point

Shoreline Characteristics	Shoreline Overtopping					Timing of Impact (100-YR)				
	Avg. Elev.	Avg. Depth (ft)	Max Depth (ft)	Length (ft)	%	USACE Low	USACE Inter.	OPC Most Likely	USACE High	OPC 1-in-200
Engineered	8.0 ft. NAVD	1.3	3.1	2,324	44.6%	Today	Today	Today	Today	Today

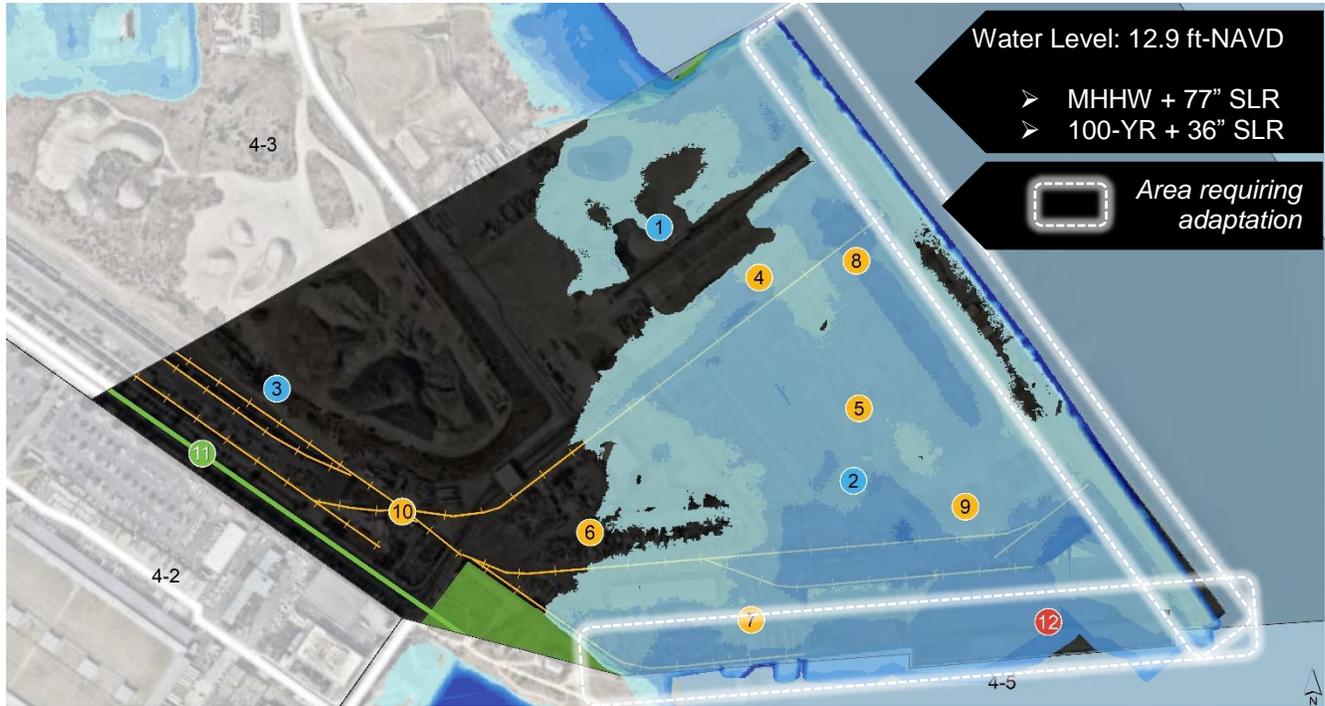
Adaptation Focus: Long-Term >2050

Shoreline Characteristics	Shoreline Overtopping					Timing of Impact (100-YR)				
	Classification	Avg. Elev.	Avg. Depth (ft)	Max Depth (ft)	Length (ft)	%	USACE Low	USACE Inter.	OPC Most Likely	USACE High
Engineered	10.1 ft. NAVD	2.8	6.5	5,217	100.0%	>2150	2144	2091	2074	2063
