Northeast Waterfront

Subarea 2-1

Subarea Description

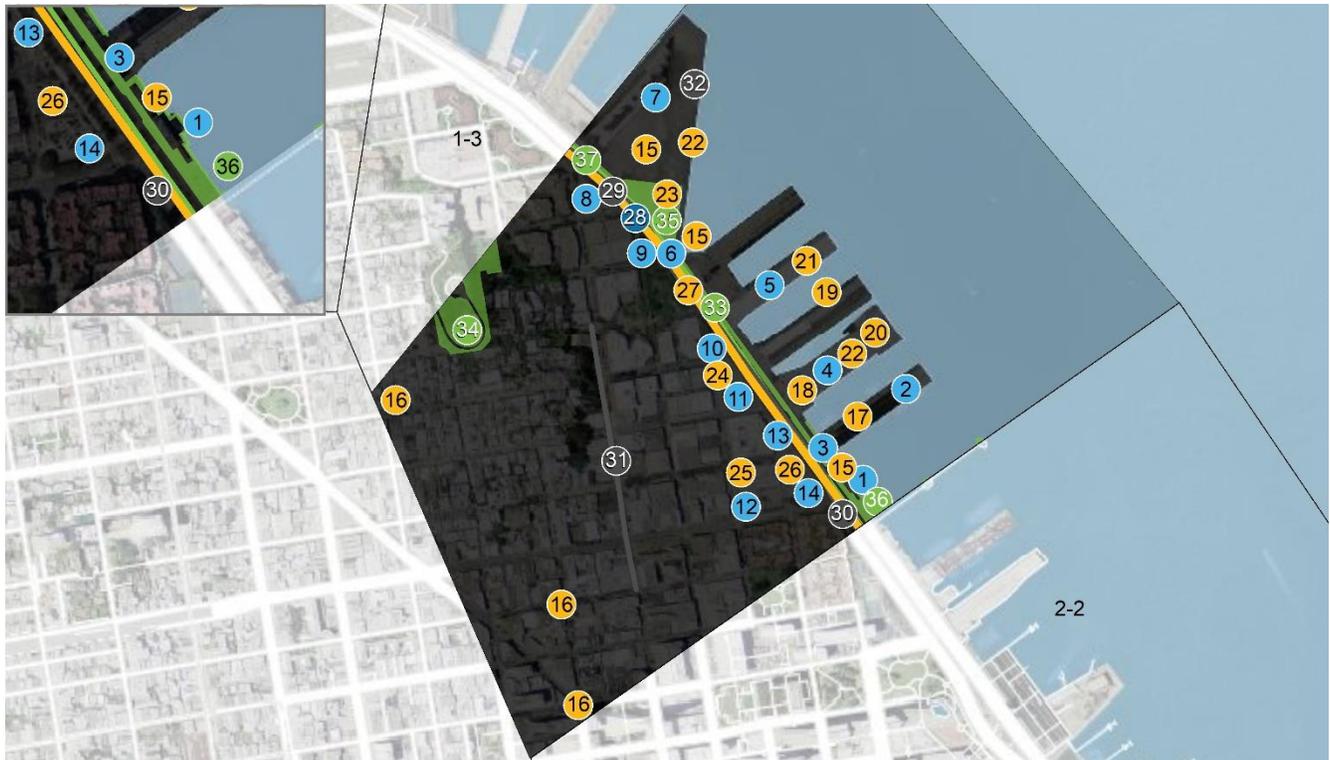
Northeastern Waterfront (Subarea 2-1) stretches from the Cruise Terminal (Pier 27-29) down to the Waterfront Restaurant and Café (north of Pier 7). Port property in this subarea includes a series of historic buildings and finger piers, bulkhead wharves, and seawall lots, which house waterfront and tourist attractions, including the Exploratorium, multiple restaurants, and the James R. Herman Cruise Terminal. Critical infrastructure further includes maritime and disaster response assets, such as large staging areas and the Water Emergency Transportation Authority (WETA) berths at Pier 9, which can support regional emergency response efforts, tugboat operators, local and regional transportation assets, and important wastewater assets, such as the North Shore Force Main and North Point Main-Sansome Tunnel.

The primary flood pathways are from overtopping along the engineered shoreline. Flooding first occurs in this subarea due to floodwaters conveyed along the Embarcadero roadway that overtops the shoreline in Subarea 2-2. Higher Bay water levels eventually overtop the shoreline in this subarea, and floodwaters extend several streets inland.

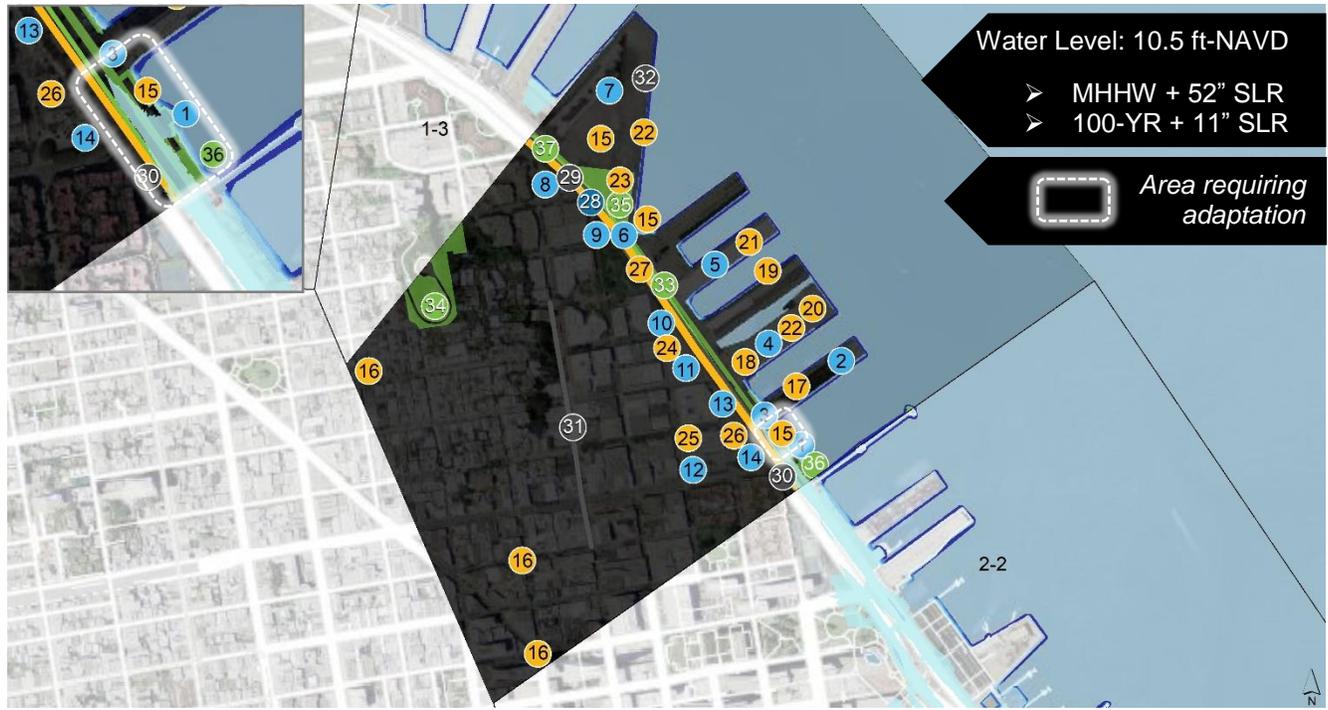
Adaptation Focus: Immediate

Shoreline Characteristics	Shoreline Overtopping					Timing of Impact (100-YR)				
	Classification	Avg. Elev.	Avg. Depth (ft)	Max Depth (ft)	Length (ft)	%	USACE Low	USACE Inter.	OPC Most Likely	USACE High
Engineered	10.5 ft. NAVD	0.1	0.1	271	2.2%	2138	2066	2044	2035	2032

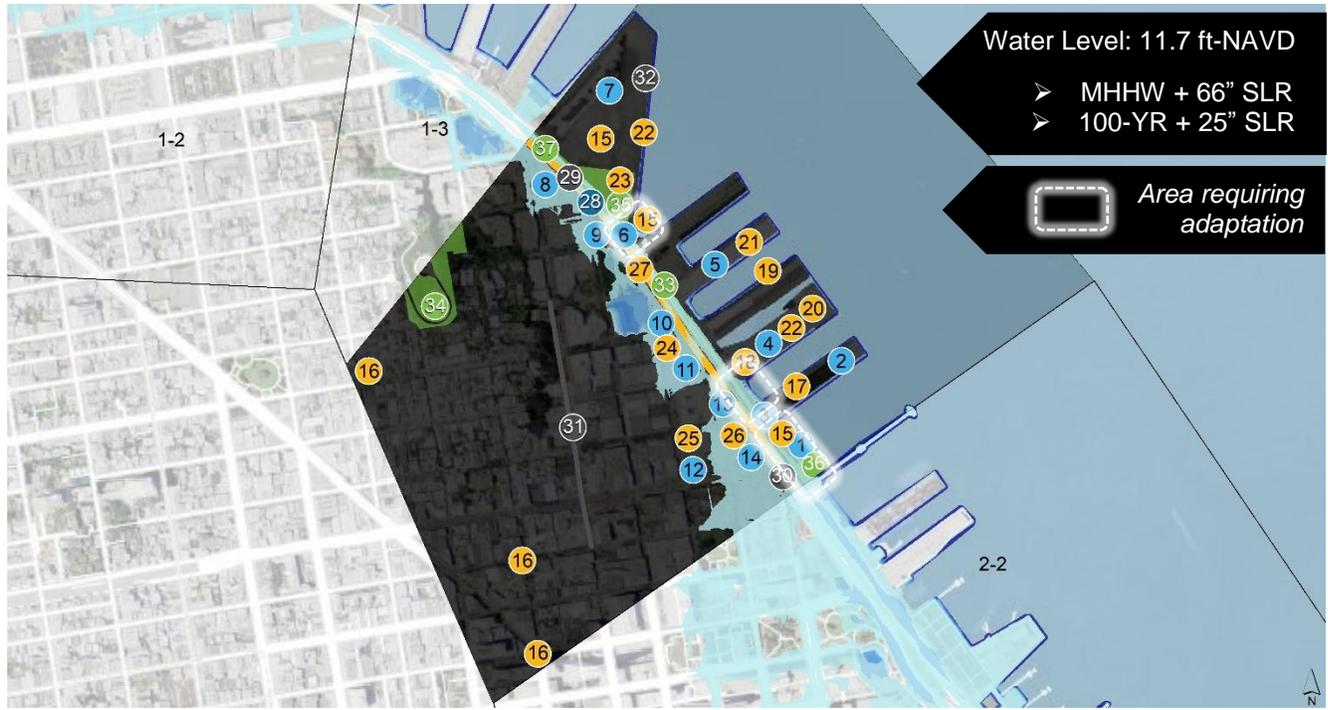
Adaptation Focus: Tipping Point

Shoreline Characteristics	Shoreline Overtopping					Timing of Impact (100-YR)				
	Classification	Avg. Elev.	Avg. Depth (ft)	Max Depth (ft)	Length (ft)	%	USACE Low	USACE Inter.	OPC Most Likely	USACE High
Engineered	11.0 ft. NAVD	0.6	1.3	1,046	8.7%	>2150	2115	2072	2060	2053

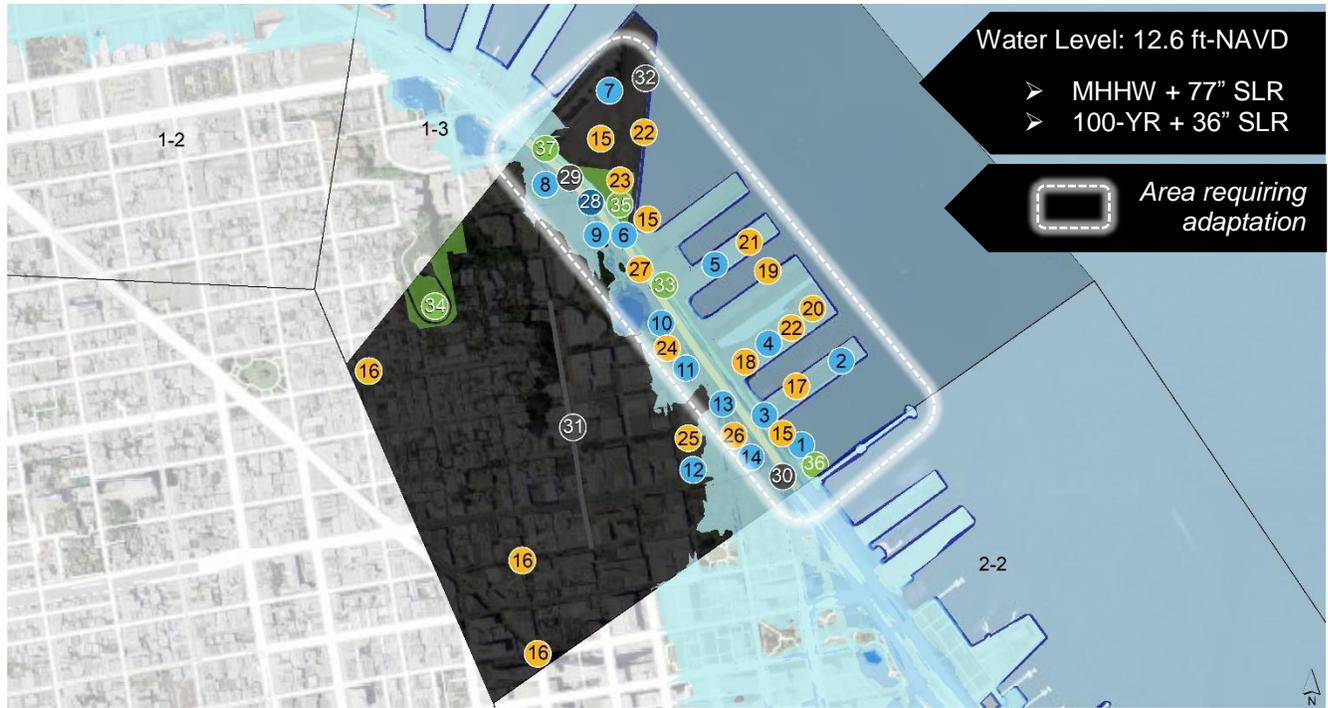
Adaptation Focus: Long-Term >2050

Shoreline Characteristics		Shoreline Overtopping				Timing of Impact (100-YR)				
Classification	Avg. Elev.	Avg. Depth (ft)	Max Depth (ft)	Length (ft)	%	USACE Low	USACE Inter.	OPC Most Likely	USACE High	OPC 1-in-200
Engineered	12.2 ft. NAVD	0.4	2.2	10,059	83.4%	>2150	2144	2091	2074	2063
